Microstructural analysis as the indicator for suitability of weld repairing of the heat resistant Cr - Ni steel^(*)

Metallurgical evaluation was performed on a fractured column tube of the reformer furnace in an ammonia plant. The tubes were manufactured from centrifugally cast heat resistant steel HK 40. Optical and scanning electron microscope (SEM) were used for microstructural and fracture analysis. For composition determination of the microconstituents energy dispersive X ray spectroscopy (EDS) was used. To evaluate mechanical properties, hardness and microhardness measurements were performed. Investigations based on the microstructural features with the idea to indicate suitability of weld repair of the column were performed in this study. It was observed that the crack initiation, caused by oxidation/corrosion and thermal stresses induced by temperature gradient, appeared in the inner side of the tube wall and propagation occurred along grain boundaries. The results clearly showed the presence of an irregular microstructure which contributed to crack propagation through the tube wall. An occurrence of precipitated needle-shaped carbides/carbonitrides and brittle σ phase was

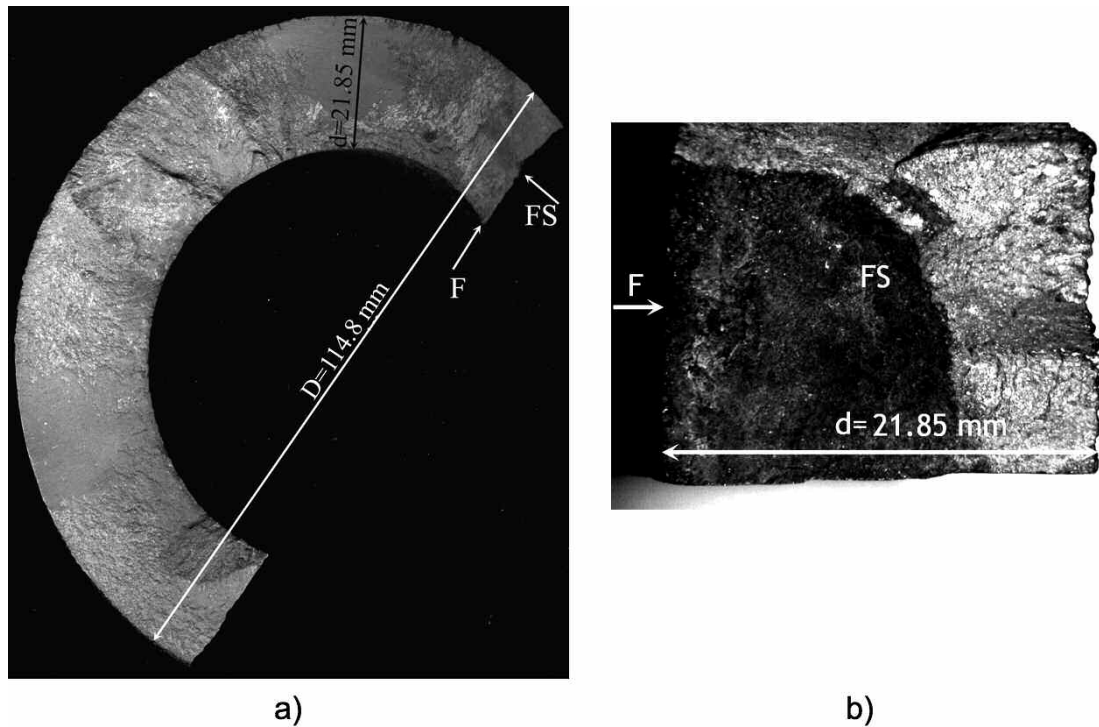
The fractured surface of the cross section of the failed tube from the upper segment A is shown in figure 2 a). Radial ridges are clearly visible, forming chevron marks of fracture pointed toward the fracture area. Dark regions near the inner and outer surfaces of the tube, with ridges pointed toward mid-wall thickness are also visible. It was found that the initial crack was originated on the inner side of the tube and marked as “F”. This crack was afterwards opened by additional deformation. The features of the fractured surfaces, in the longitudinal direction of the tube, are presented in figure 2 b) and denoted as FS. Two distinctive areas are clearly visible: a dark, semicircular area with an oxide film, and a light area as a result of the fresh crack opening. The crack propagation direction was perpendicular to the tube wall and was branched to the 2/3 of the wall thickness. In this area two zones may be identified. The first zone at the inner wall of the tube, width 2 to 3 mm in thickness, is characterized by unidirectional configuration, whereas the second zone is distinguished by fan-like ridges directed to the inner surface of the tube. According to dark colour (Fig. 2 b)) it could be concluded that this surface was formed before the final fracture of the tube along the tube cross section.

Figure 2. Fractured surface of the tube: a) cross section; b) longitudinal direction. F denotes the location of fracture and FS denotes fractured surface.

The results indicate that the catastrophic failure of the tube was not initiated on the cross section of the wall of the bulk material. The morphology of the fractured surfaces shown in figure 2 is the result of progressive fracture and suggests that it is caused by thermal and mechanical strain. There is no evidence of creep or fatigue damage during service life. The analysis of longitudinal fractured surfaces reveals that the crack growth was a long-time process and was initiated on highly oxidized surfaces at the inner side of the wall. It could be concluded that crack growth was induced by thermal strains as a result of a temperature gradient along the wall thickness of the tube. Also, it is highly possible that thermal shock has to be taken into account as a support for the crack propagation.

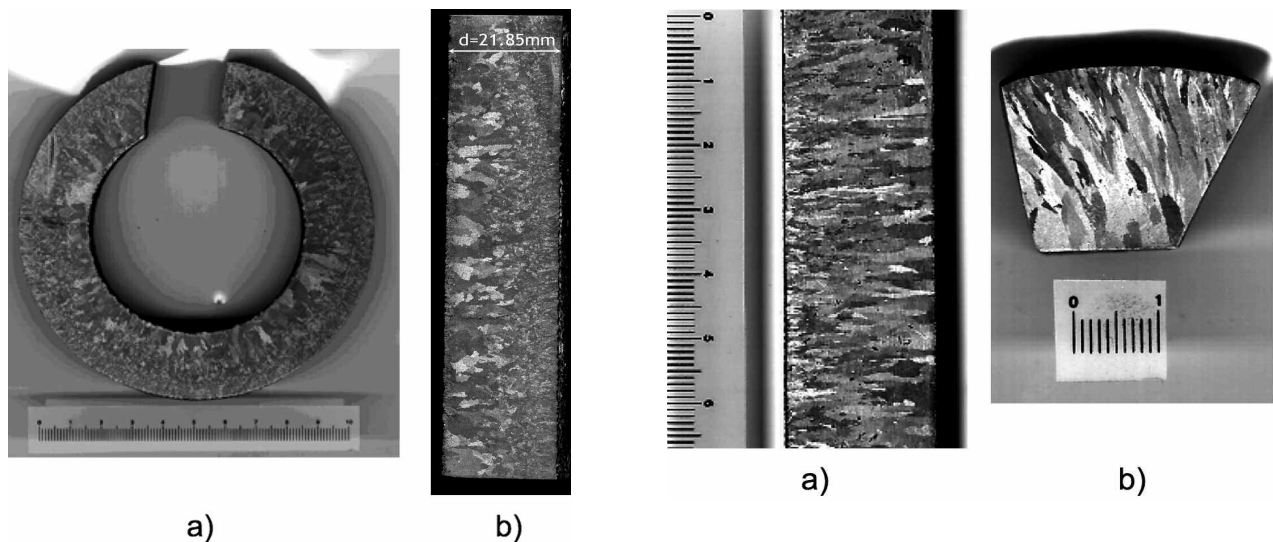
The macrostructure of the tube segments A and B, in both directions, is presented in figures 3 and 4, respectively. Fine equiaxed grains next to the outer tube wall which cover from 1/3 to 2/3 of the wall thickness are shown in figure 3. The columnar structure is only found partially in the microstructure. On the other side, the macrostructure of the tube segment B consists of fine equiaxed grains next to the outer tube wall and coarse undirected grains next to the inner tube wall (Fig. 4). Elongated columnar grains oriented in a radial direction and covering more than 2/3 of the wall thickness are located in the interspaces.

Figure 3. Macrostructure of the segment A. a) cross section of the tube, sample 10; b) longitudinal direction of the tube, sample 5. Etched in the Aqua regia.

Macrostructural characteristics of segment A (Fig. 3) cannot meet the requirements proposed for sound cast structure. For this particular purpose such macrostructure must have fine equiaxed grains on the outer side of tube wall, coarse equiaxed grains near the inner side of the tube, and elongated columnar grains between these two regions. The

shape, size, orientation and proportion of the columnar grains play an important role in the fracture resistance of the steel. The zone with elongated columnar grains should be more than half of the wall thickness^[2]. In the case of this class of high-temperature steels, cracks spread intercrystallinely and in this case the size, shape and orientation of grains have a dominant influence on crack growth. These factors, as well as the fraction of elongated columnar grains, are the result of casting and solidification conditions^[1-4]. As a result of improper centrifugal casting and solidification processes, an irregular macrostructure with majority of equiaxed crystals without elongated columnar crystals zone was

detected. These facts eliminate the macrostructure of the segment A as suitable for weld repair. On the other side, macrostructure of segment B is in accordance with requirements for recommended macrostructure.

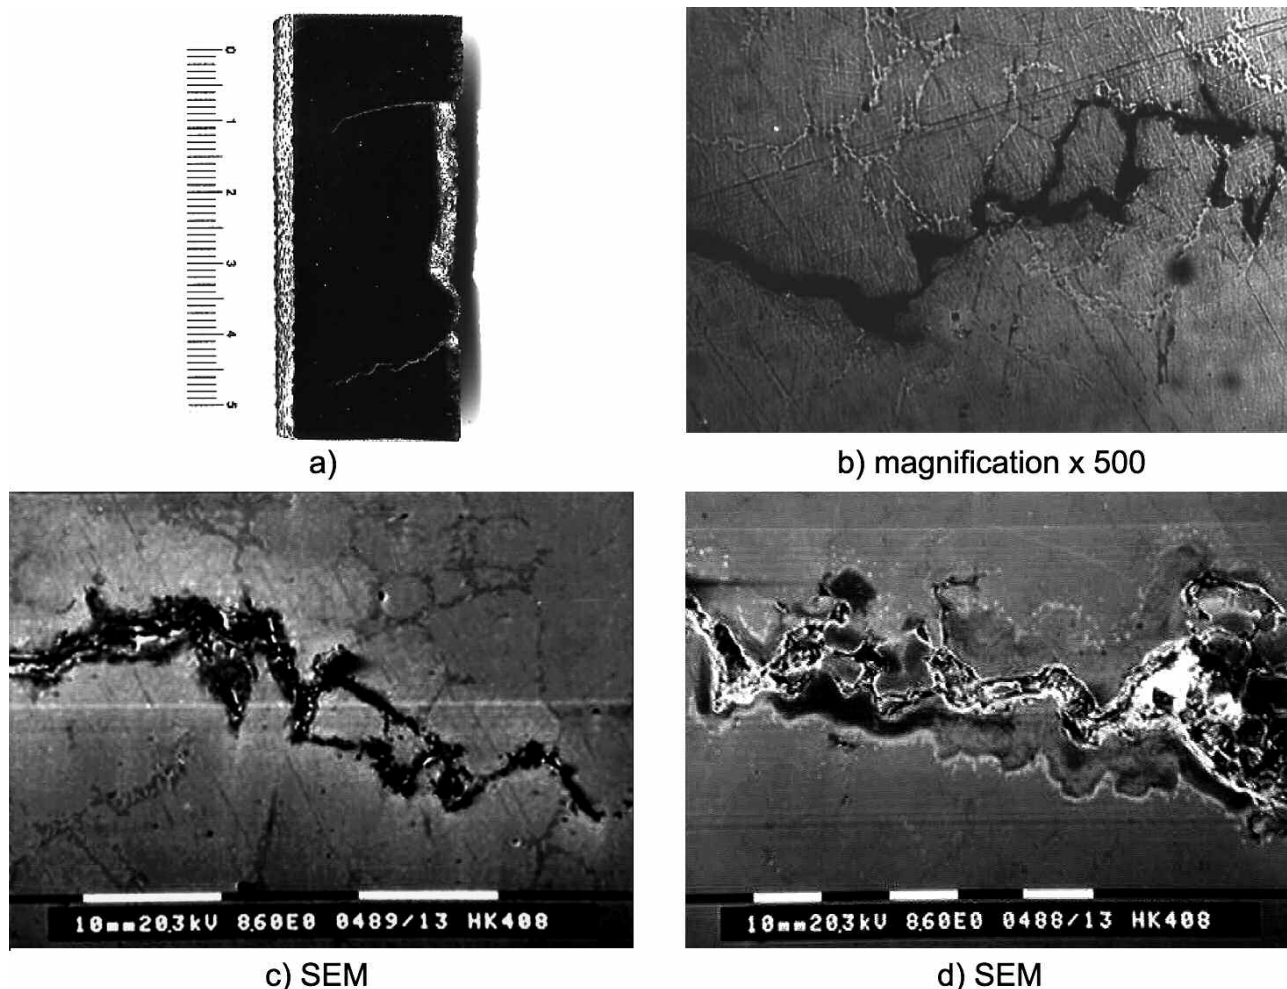
the average depth of 300 μm . The branching of the radial and axial cracks directed from the inner to the outer surface of the tube in the longitudinal sample is illustrated in figure 5 a). It is evident that the cracks are propagated along the grain boundaries of the austenite grains, as shown in figure 5 b). The presence of oxidation and/or carbonization products in the bulk of the crack is visible in figure 5 c) and d) obtained by SEM.

Figure 5. Crack branching from inner to outer side of the tube through the wall thickness. a) Macro view; b) Optical microscope; c) and d) SEM image of the crack end. Polished and etched.

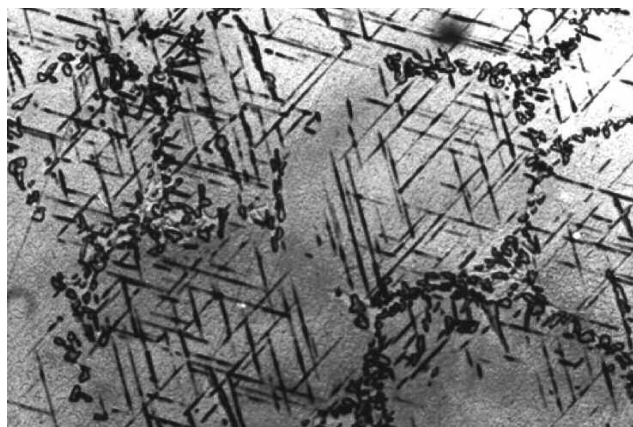
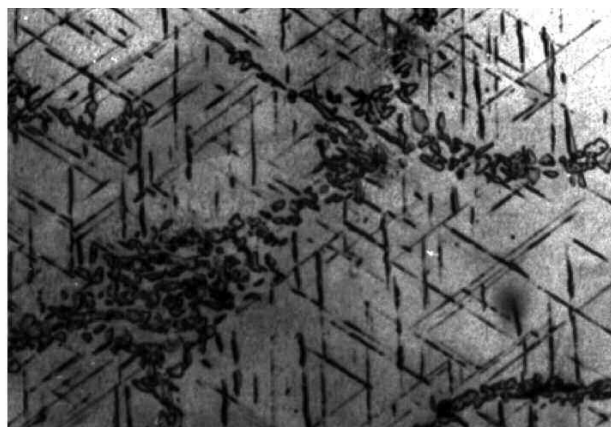
Microstructures of the bulk material from the tube segment A analyzed by light microscope, in cross section and in the longitudinal direction, are presented in figure 6. The microstructure is distinguished by the austenite matrix with precipitated globular eutectic carbides located at grain boundaries, needle-like precipitated carbides and carbonitrides within the grains.

The difference in morphology of carbides precipitated at the grain boundaries at the inner and outer side of the tube wall may be observed. Needle-like precipitates inside the grains from the outer side of the wall are coarser and longer than those at the inner side of the tube. Details of the microstructure analyzed by SEM and EDS are shown in figure 7. The presence of austenite matrix with massive precipitates at the grain boundaries was revealed in figure 7 a). Globular gray phase which could be precipitated σ -phase was evidenced at the grain boundaries. Dispersed secondary needle-shaped carbides/carbonitrides within grains were also identified. EDS analysis of the matrix is shown in figure 7 b). The atomic spectrum of precipitates and grain boundaries is shown in figure 7 c). Precipitates were enriched in Cr and depleted in Ni. The presence of non-metallic

Figure 6. Microstructure of the bulk material from segment A obtained by optical microscope. a) Tube wall cross section; b) Tube wall longitudinal direction. Etched in Aqua regia.

burner, pearl-shaped carbides were identified at grain boundaries, which indicates a probable overheating of the tube material above the working temperature. This type of microstructure is regarded as unfavourable for steel weldability. Precipitated needle-shaped carbides/carbonitrides as well as brittle σ-phase at grain boundaries and within grains (Figs. 6 and 7) were also identified in the microstructure. The results of the microhardness measurements identified the presence of precipitates with higher hardness at grain boundaries of the segment A. The fact that the difference exists between microstructures of segment A and B is confirmed by results of hardness testing (Table V) with significantly higher values of segment A hardness. The presence of the needle-shaped high hardness precipitates, causing brittleness of the material, intensively reduces weldability. The morphology and high hardness of the microconstituents in the microstructure of the segment A indicates that solution annealing before welding could not recover the microstructure for weld repair.

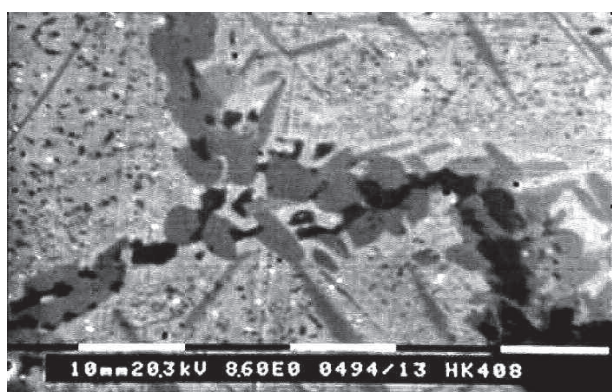
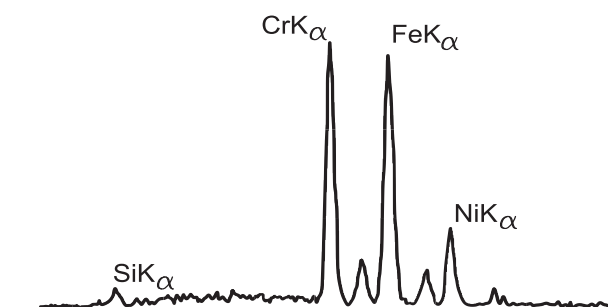
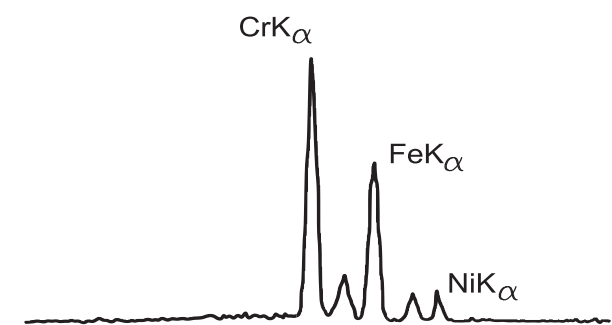
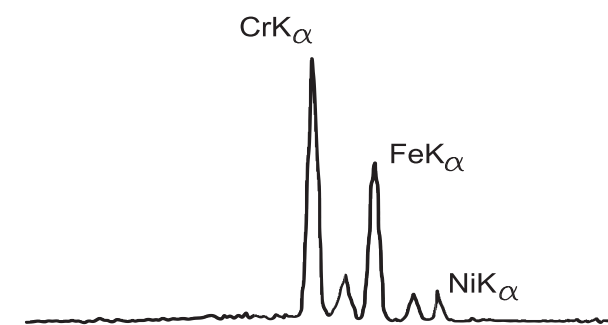
Figure 7. Microstructural analysis of the tube material from fractured segment A. a) SEM; b) EDS analysis of the matrix; c) EDS analysis of the grain boundary - gray phase; d) EDS analysis of the sulphide inclusion - black phase.

inclusions found as dark phase mainly corresponds to MnS-type inclusions (Fig. 7 d)).

Chemical composition of the matrix and microconstituents is shown in table III. From the ratio of Fe/Cr it could be deduced that these precipitates are carbides, whereas carbides within grains are of M_7C_3 -type and the grain boundaries precipitates correspond to σ - phase and M_6C -type carbides^[8].

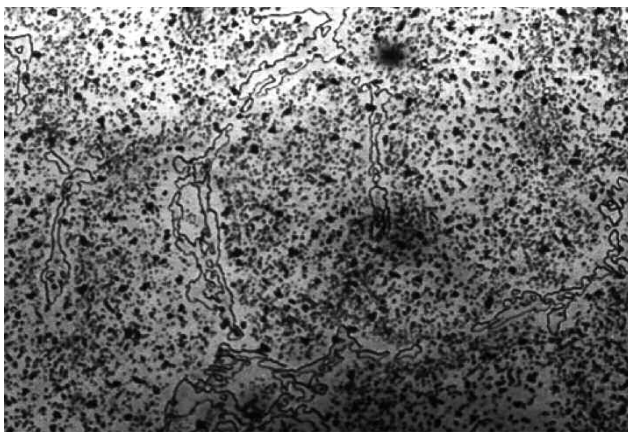
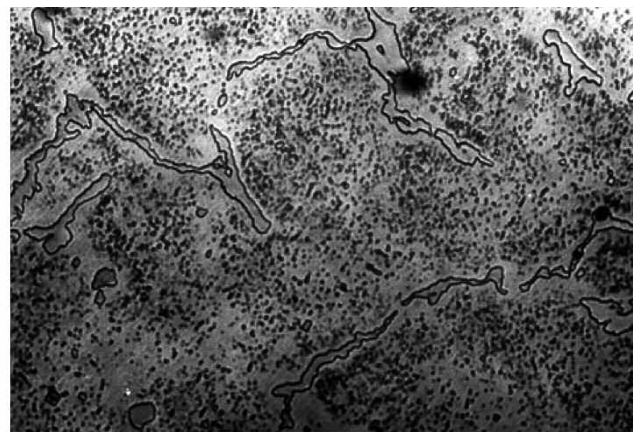
Microstructures of samples from segment B above collector are shown in figure 8. Analysis was performed by optical microscope in longitudinal and transverse direction. The same pattern for sampling areas was applied with sample A. The microstructure

is austenite matrix with precipitated eutectic carbide phase dispersed at grain boundaries and fine carbides within grains. The volume fraction of carbides is significantly lower at the grain boundaries compared to carbides within grains. There is no distinct difference of the microstructure in shape, volume and distribution between the inner-side, the mid-wall thickness and the outer-side samples. The same is valid for the longitudinal and transversal directions.

Figure 8. Microstructure of the bulk material from segment B obtained by optical microscope. a) Tube wall cross section, sample 8 from figure 3; b) Tube wall longitudinal direction, sample 9 from figure 1. Etched in Aqua regia.

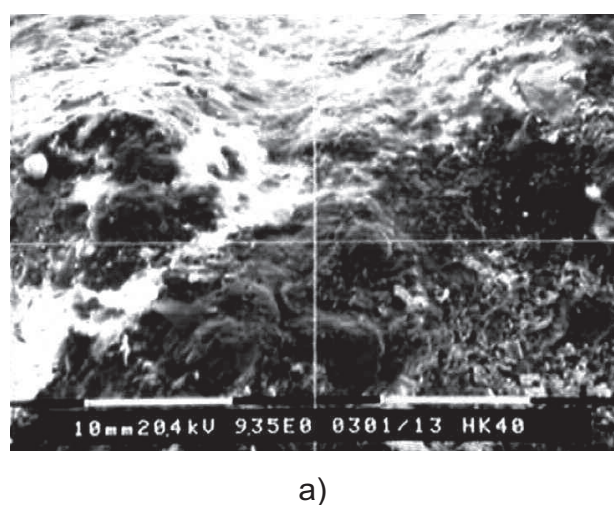
The results of the fracture analysis by SEM are shown in figures 9 and 10. The crack initiation site, which is shown in figure 2 b) (segment A) as a dark semicircle surface, is shown in figure 9 a). Spectrum analysis has shown that, besides the expected elements (Fe, Cr, Ni and Si), Al- and Ca-based compounds were also detected. The characteristic fracture surfaces are shown in figure 10. It is evident that the crack was initiated and propagated on the dendrite boundaries where corrosion products were located. The fracture surface where the crack was intergranularly extended along the dendrite grain boundaries is illustrated in figure 10 a), where as figure 10 b) shows an area with presence of secondary cracks. The transition area where a transgranular fracture is found may be seen in figure 10 c). The final opening of the crack by tearing is shown in figure 10 d).

Figure 9. Image of the fracture initiation. a) SEM; b) EDS analysis of corrosion products.

of the fracture initiation and propagation mechanisms. The fracture was initiated on oxidation/corrosion products from the inner side of the tube wall. The crack propagates intercrystally, i.e. along the grain boundaries of fine dendrites. Secondary cracks were also identified, as shown in figure 10. The final stage of fracture was of the cleavage type, when the crack propagates transcrystally. The presence of oxidation/corrosion products in the material of the segment A, the existence of fine dendrites without columnar structure, and the occurrence of the secondary cracks, deteriorate weldability, giving the evidence that the investigated material is unsuitable for weld repair.

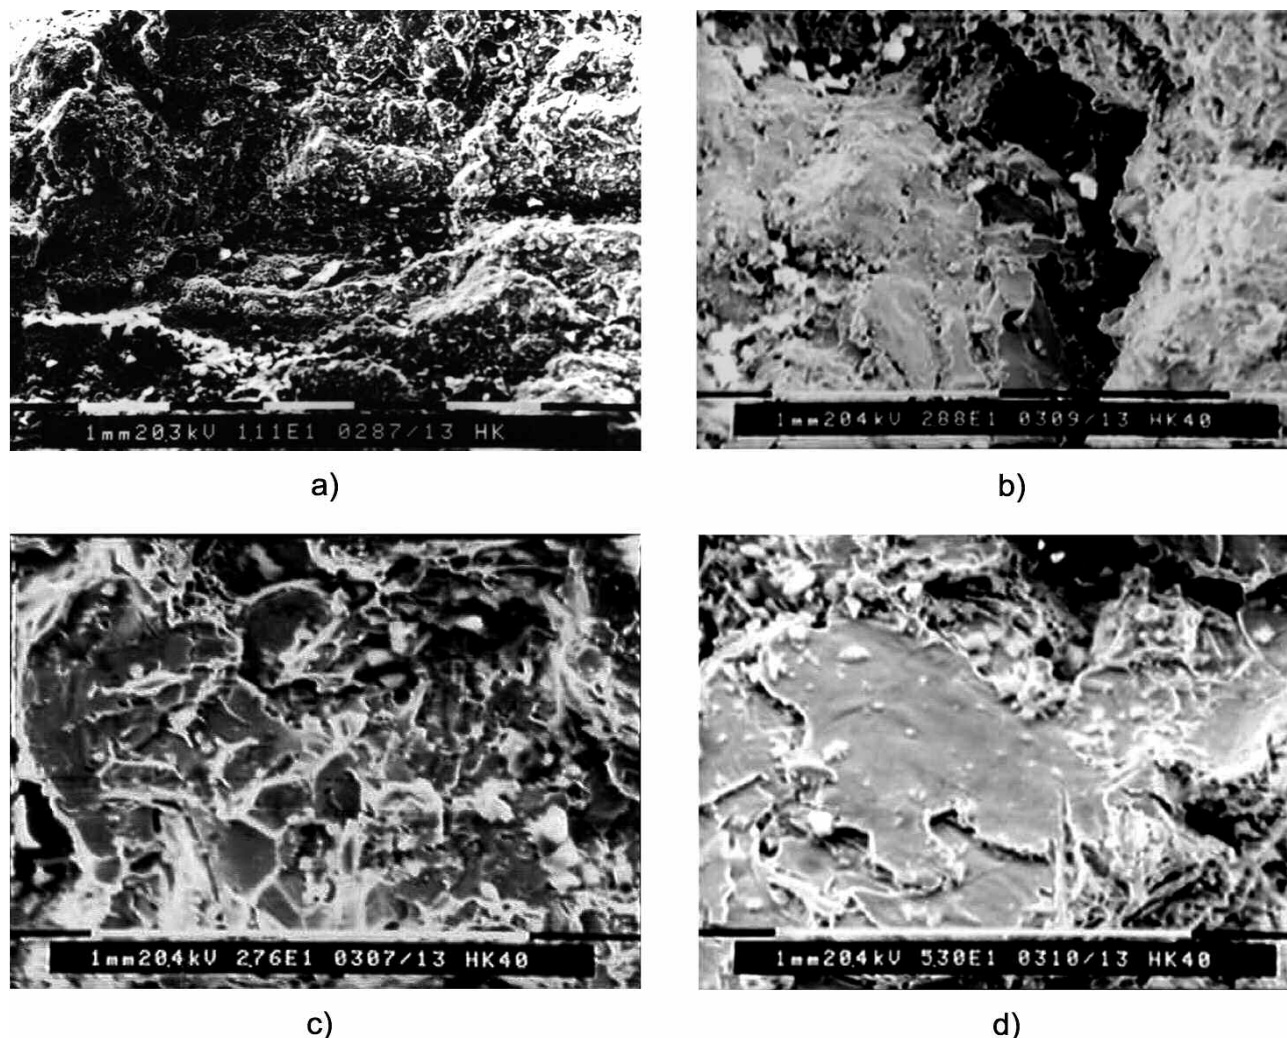
Figure 10. SEM images of the fractured tube. a) Surfaces with crack extended along dendrite grain boundaries – intergranularly; b) Area with the presence of secondary cracks; c) Final stage of transgranular fracture; d) Surface of the crack opening by tearing.

eliminate microstructure of the segment A as suitable for weld repair. The presence of precipitated hard, needle-shaped carbides/carbonitrides, as well as brittle σ -phase at grain boundaries and within grains, gave a strong indication that the investigated microstructure does not meet the requirements for weld repair at the spot of fracture. This structure is not suitable for high temperature heat treatment annealing for recovering and preparing for weld repair. Under these circumstances, the replacement of the whole tube should be recommended.
