ANALIZA SLEGANJA TEMELJA USLED PROGRESIVNOG PROVLAŽAVANJA PRAŠINASTIH GLINA^{**}**

ANALYSIS OF FOUNDATION SETTLEMENT FROM PROGRESSIVE MOISTENING OF SILTY CLAY^{**}**

Examples of visible damage (cracks on the facade walls) on the shallow founded older buildings in Belgrade are not rare. Usually, this is a consequence of unequal settlement resulting from the unexpected moistening of soil under foundation. Moistening usually occurs locally and differential settlement is inevitable in such conditions. This paper presents the research results, which indicate that besides the size of impact zone of moisture change in the soil in horizontal direction and calculated settlement values, total change of soil volume under foundations should be analyzed.

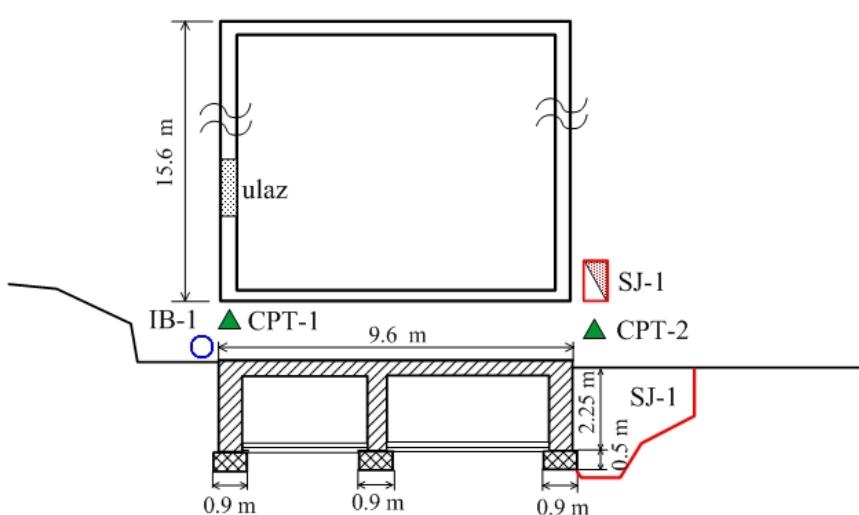
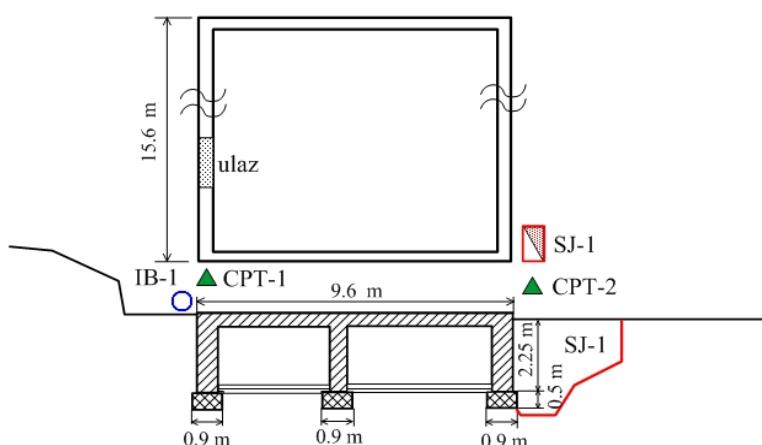
istraživanja su obuhvatala iskop jedne istražne jame (SJ-1) u zoni najvećih oštećenja tj. prepostavljenoj zoni provlažavanja, izvođenja jedne istražne bušotine (IB-1) van zone provlažavanja, dve statičke penetracije (CPT-1 i CPT-2) i geomehanička laboratorijska ispitivanja. Situacija objekta sa položajem istražnih radova prikazana je na slici 2.

Conducted geotechnical investigations included the excavation of an exploration pit (NS-1) in the zone of greatest damage, i.e. assumed moistening zone, carrying out one exploration hole (IB-1) outside the zone of moistening, two static penetrations (CPT-1 and CPT-2) and geomechanical laboratory testing. The situation facilities with the exploration works is shown in Figure 2

Fig. 2. Review of facility founding with a position of exploration works

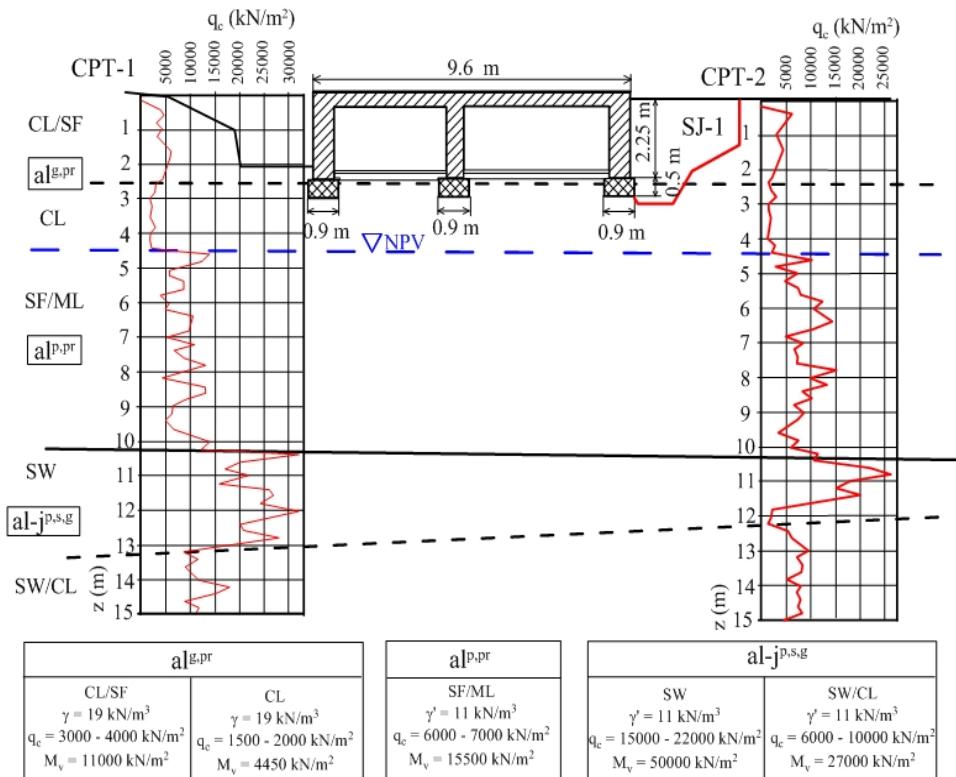
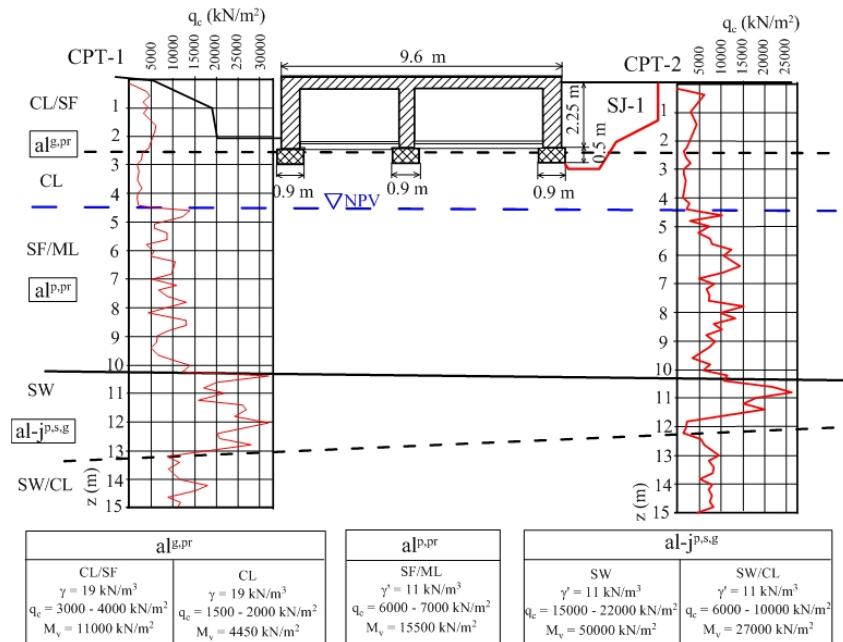
pit have shown that the ground is made of the following lithological members (Figure 3):

Fig. 3. Geotechnical section of the ground

As the field explorations have reliably established that the damage of facilities was caused by moistening the layer of silty clay and dust, Table 1 gives the summary results of laboratory tests only for this environment [5].

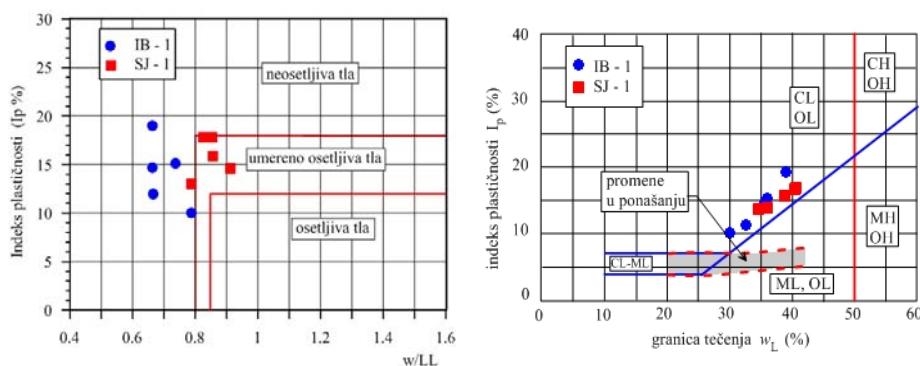
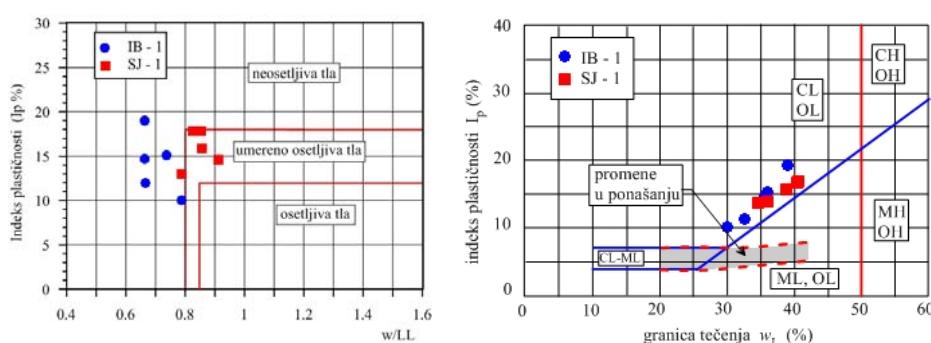
In addition, it should be noted that the obtained values of consistency limits and corresponding index indicators, suggest that silty clay in the zone, according to the criteria of Bray and Sancio[6], [7], can be classified into moderately sensitive soils, in terms of danger of liquefaction occurrence, related the fine-grained environments.

Fig. 4. Analysis of risk assesment from liquefactionooccurrence according to the criteria
a) Bray and Sancio (2006) and b) Boulanger and Idriss (2006)

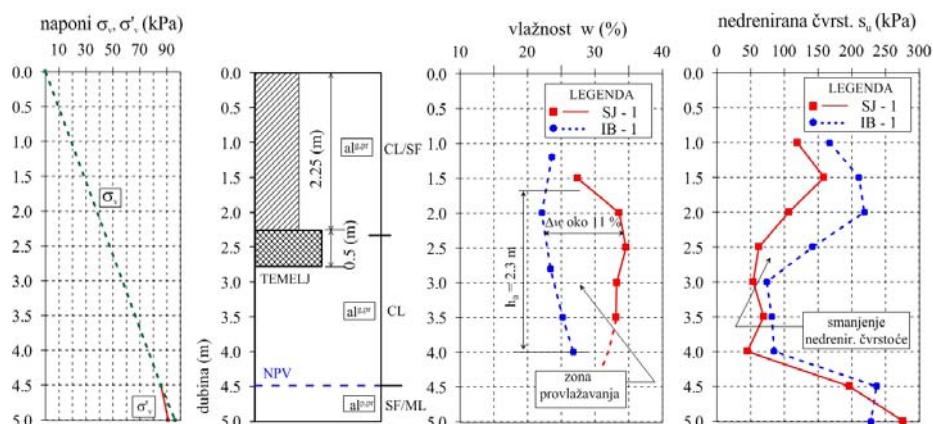
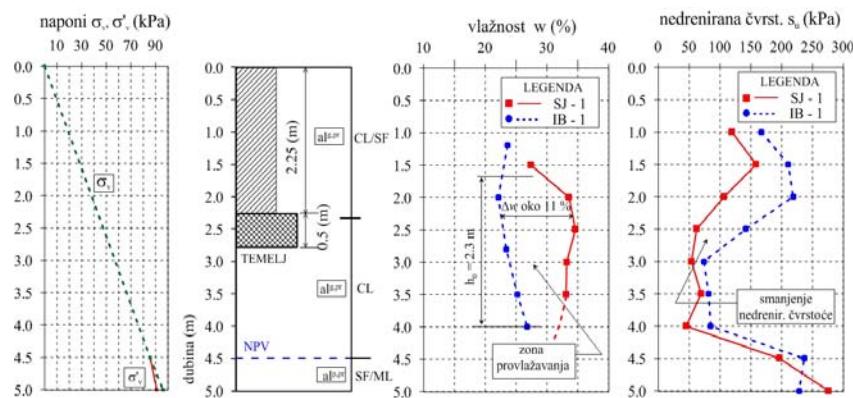
Therefore, some other possible causes of damage have to be found out. If the results of soil moisture changes with depth are analyzed, it will be seen that, in the moistening zone, the moisture is increased of about $w = 11\%$. These results of soil moisture changes with depth, for both geotechnical models, are presented in Figure 5 in the form of diagrams. Although the exploration pit (NS-1) was made to a depth of 3.5 m, it can be observed from a diagram that increased soil moisture also appears in the vertical direction to the certain depth h_0 . In this case, the average vertical depth of moisture changes is about $h_0 = 2.3$ m (from e.g. 1.7 m to 4.0 m). It can also be taken into account the fact that the zone of soil moistening the degree of saturation is $S_r = 100\%$. The nondrained shear strength was determined on the basis of the results of static penetration tests, using the theoretical dependence in the form $q_c = N_k s_u + \sigma_v$ (for N_k the adopted maximum value of 25).

Fig.5. The use of physico-mechanical properties in the function of depth

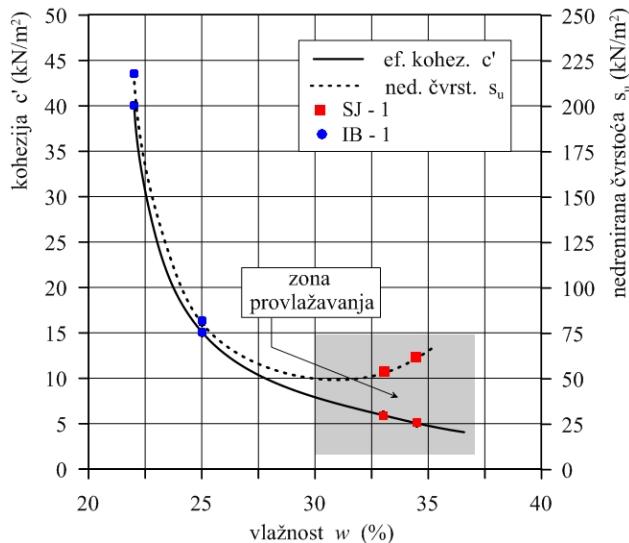
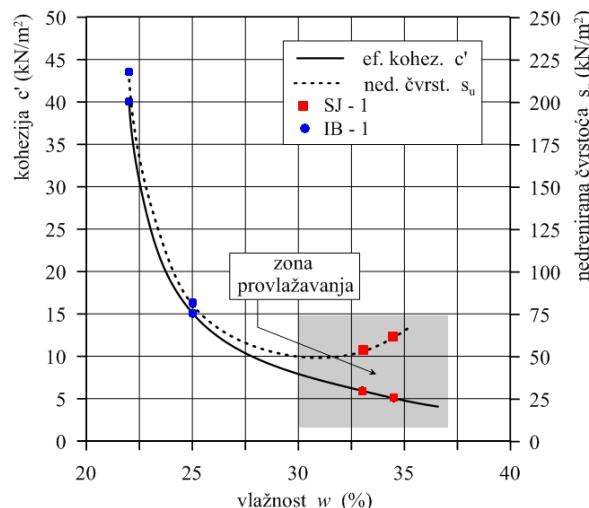
As the construction was built of a brick in lime mortar, and it is several decades old, it can be concluded that the consolidated settlement ended, and thus obtained values represent additional uplift due to intense moistening. It happened in a short distance, so the facility could not possibly accept such deformations. The cracks point out to it with a width in the ground floor is higher. In any case, the main cause of damage of the facility is certainly moistening the foundation soil, and mostly due to a damage of gutter systems. However, when it is a fact with

dusty materials with moistening, the washing of very fine particles is possible, which also leads to the volume change [9]. This process of changes the physico-

Fig. 6. Reduction of shear strength of soil under facility due to moistening

Based on the conducted investigations and analyses, it can be concluded that the unintended soil moistening occurs in a particular affected zone by changes in moisture, which is, for example in the horizontal direction, in the case of the tested silky clay ($al^{g,pr}$) relatively small, $L < 2.0$ m. As the soil moistening has mainly the local character, so the zone of subsequent settlement has the local level. The consequence of this is the appearance of differential settlement in a very short distance, which can cause minor or major damage on the facility. To return the facility in exploitation condition, it is necessary to make its rehabilitation, which must include the foundation repair, rehabilitation of system for controlled discharge of surface and storm water and

rehabilitation of the structure. All these measures of rehabilitation require much higher financial resources than those needed to build and maintain a system that should prevent the moistening of foundation soil.
