ANALYSIS OF CAUSES OF DEGRADATION OF PARENT MATERIAL AND WELD METAL OF BREECHES PIPE AT HYDRO POWER PLANT 'PERUĆICA'

Originalni naučni rad / Original scientific paper

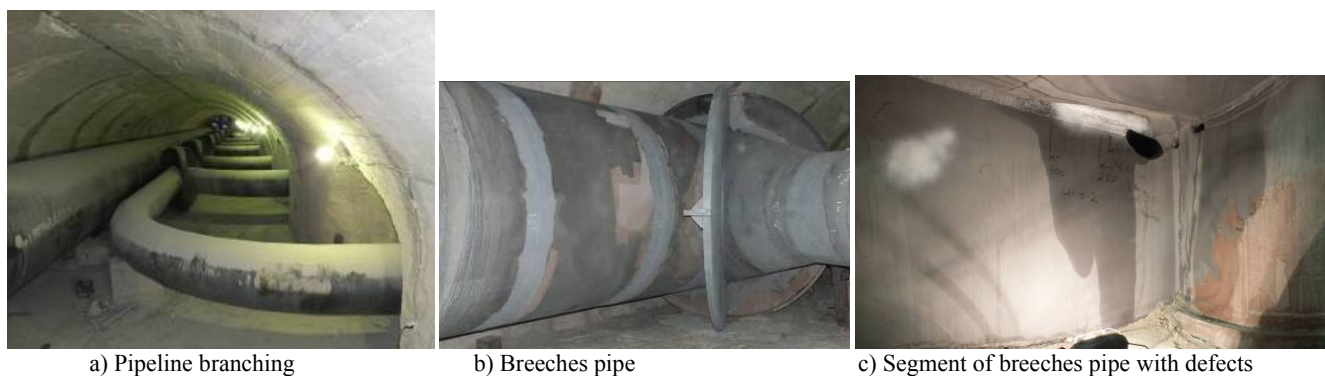
Figure 4. Pipeline III with defects in parent material and welded joints.

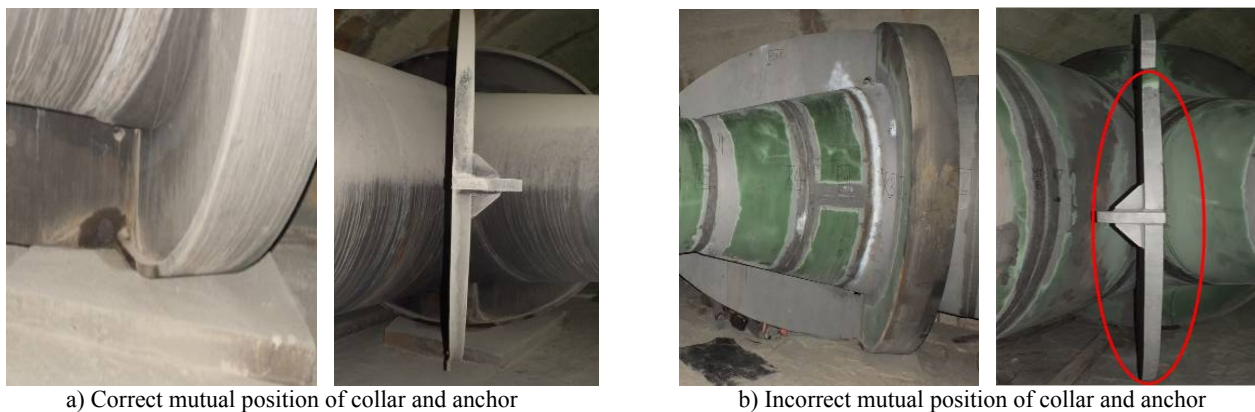
in that area, which occur during the process of performing in-service functional tasks (stationary and dynamic loads) and during the disturbed process of exploitation (non-stationary dynamic loads), led to the increase of the level of damaging of the parent material and welded joints at the structural parts of the breeches pipe (collars and anchors), which endangers the integrity of the pipeline structure as a whole, Fig. 4. The role of the collar, over which the breeches pipe leans on the foundation, is to receive static and dynamic loads (mean pressure in the pipeline of 61 bar, specific load caused by the quantity of water in the pipeline, effect of gravitational force) and displacements that occur due to non-stationary dynamic loads, while the anchor has the role in strengthening and balancing the mass of the breeches pipe. Significant propagation of the defect at the carrying structure of breeches pipe no.1, mostly at parent material of the anchor and welded joint, between the collar and the anchor, as well as between the pipeline and the anchor, has led to the fact that in 2012 the breeches pipe started to lean not on the collar, but on the anchor, Fig. 5b.

a) Correct mutual position of collar and anchor
 b) Incorrect mutual position of collar and anchor
 Figure 5. Correct mutual position of collar and anchor at breeches pipe and the damage at the anchor caused by bending initiated by incorrect mutual position of collar and anchor (bending of the anchor is shown in Fig. 5b).

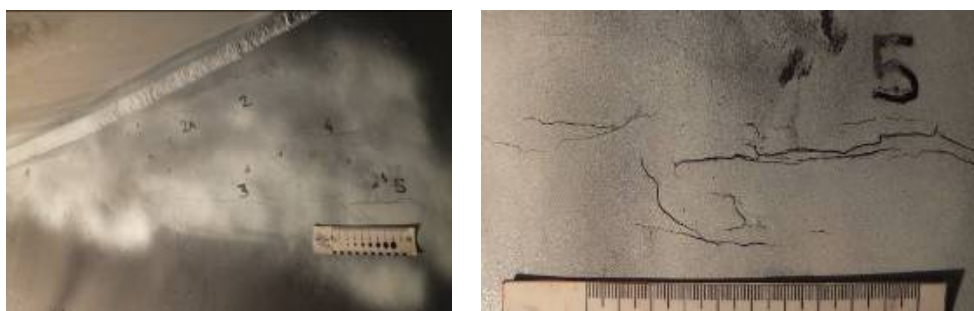
Examples of defects detected at parent material (PT), heat-affected zone (HAZ) and weld metal (WM) of the breeches pipe no.1 through visual (VT), /2/, and magnetic particle testing (MT), /3/, are shown in Figs. 7-9. It is determined through ultrasonic testing (UT), /4/, that cracks in parent material presented in Figs. 7 and 8 are 13-32 mm deep, while cracks in the weld metal are 25-52 mm deep.

Figure 7. Cracks at the surface of parent material of the anchor of breeches pipe no.1.

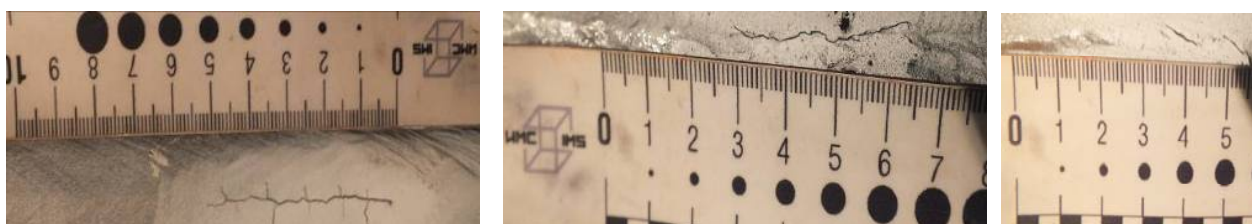
a) Cracks at the surface of WM
 b) Cracks in the HAZ
 c) Cracks at the surface of PM

Figure 8. Appearance of cracks detected at parent material and welded joints of breeches pipe no.1.

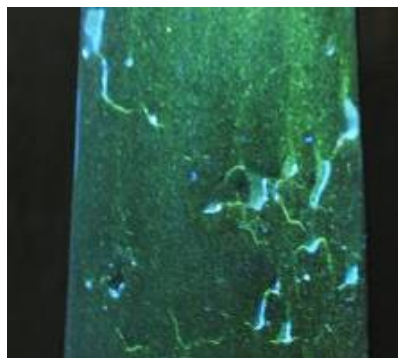
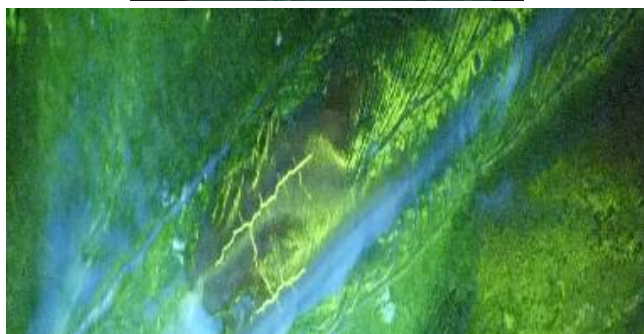
Figure 9. Defects detected in parent material and welded joints of anchor of breeches pipe no.1.
