Case study

Failure analysis of the mobile elevating work platform

Srđan M. Bošnjak^{a,*}, Nebojša B. Gnjatović^a, Dejan B. Momčilović^b,
Ivan L.J. Milenović^a, Vlada M. Gašić^b

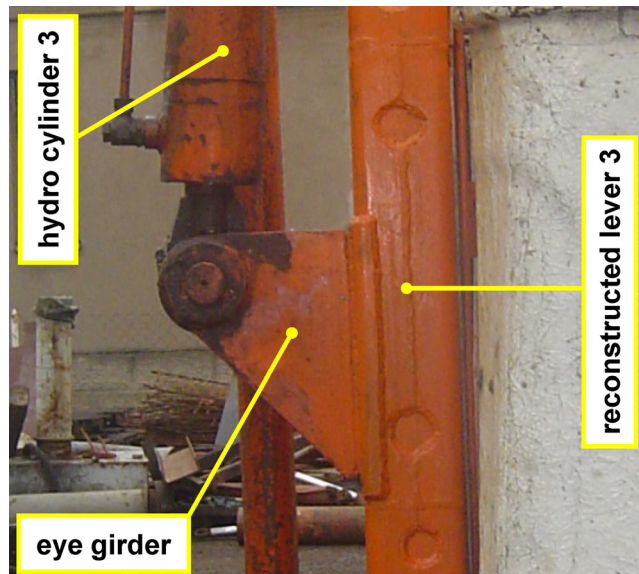
Fig. 6. Detail of the reconstructed lever 3.

Due to the fact that the undamaged eye girder was mounted on the reconstructed lever 3, Fig. 6, all examinations were performed on specimens sampled from the damaged part of lever 3, Fig. 7.
