REPAIR OF CRACKS DETECTED IN CAST COMPONENTS OF VERTICAL KAPLAN TURBINE ROTOR HUB

Originalni naučni rad / Original scientific paper
UDK /UDC: 621.791:621.22

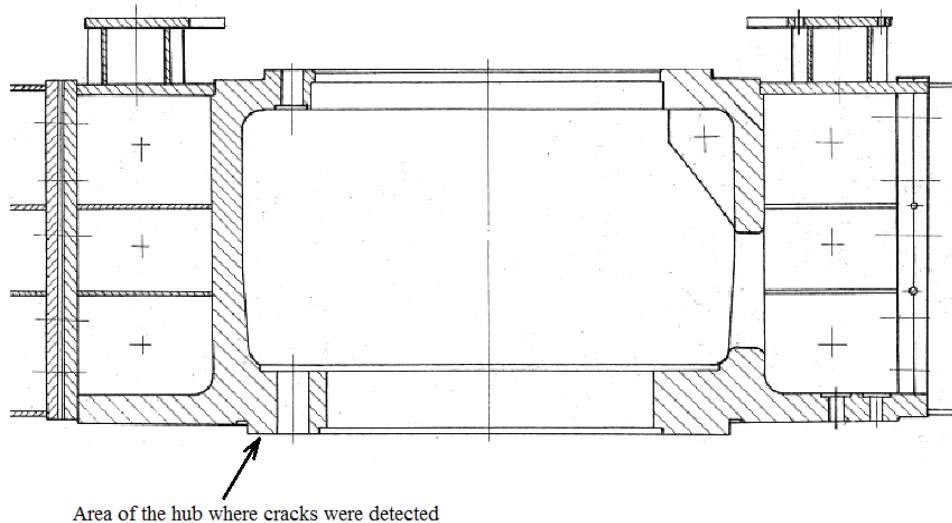
odic inspections and state analyses. Basic components of the hydroelectric generating station A4 turbine are presented in Fig. 1. The generator rotor is presented in Fig. 2, while the cast part of the rotor hub with the marked area where cracks were detected is presented in Fig. 3.

Area of the hub where cracks were detected

Figure 3. Generator rotor hub.

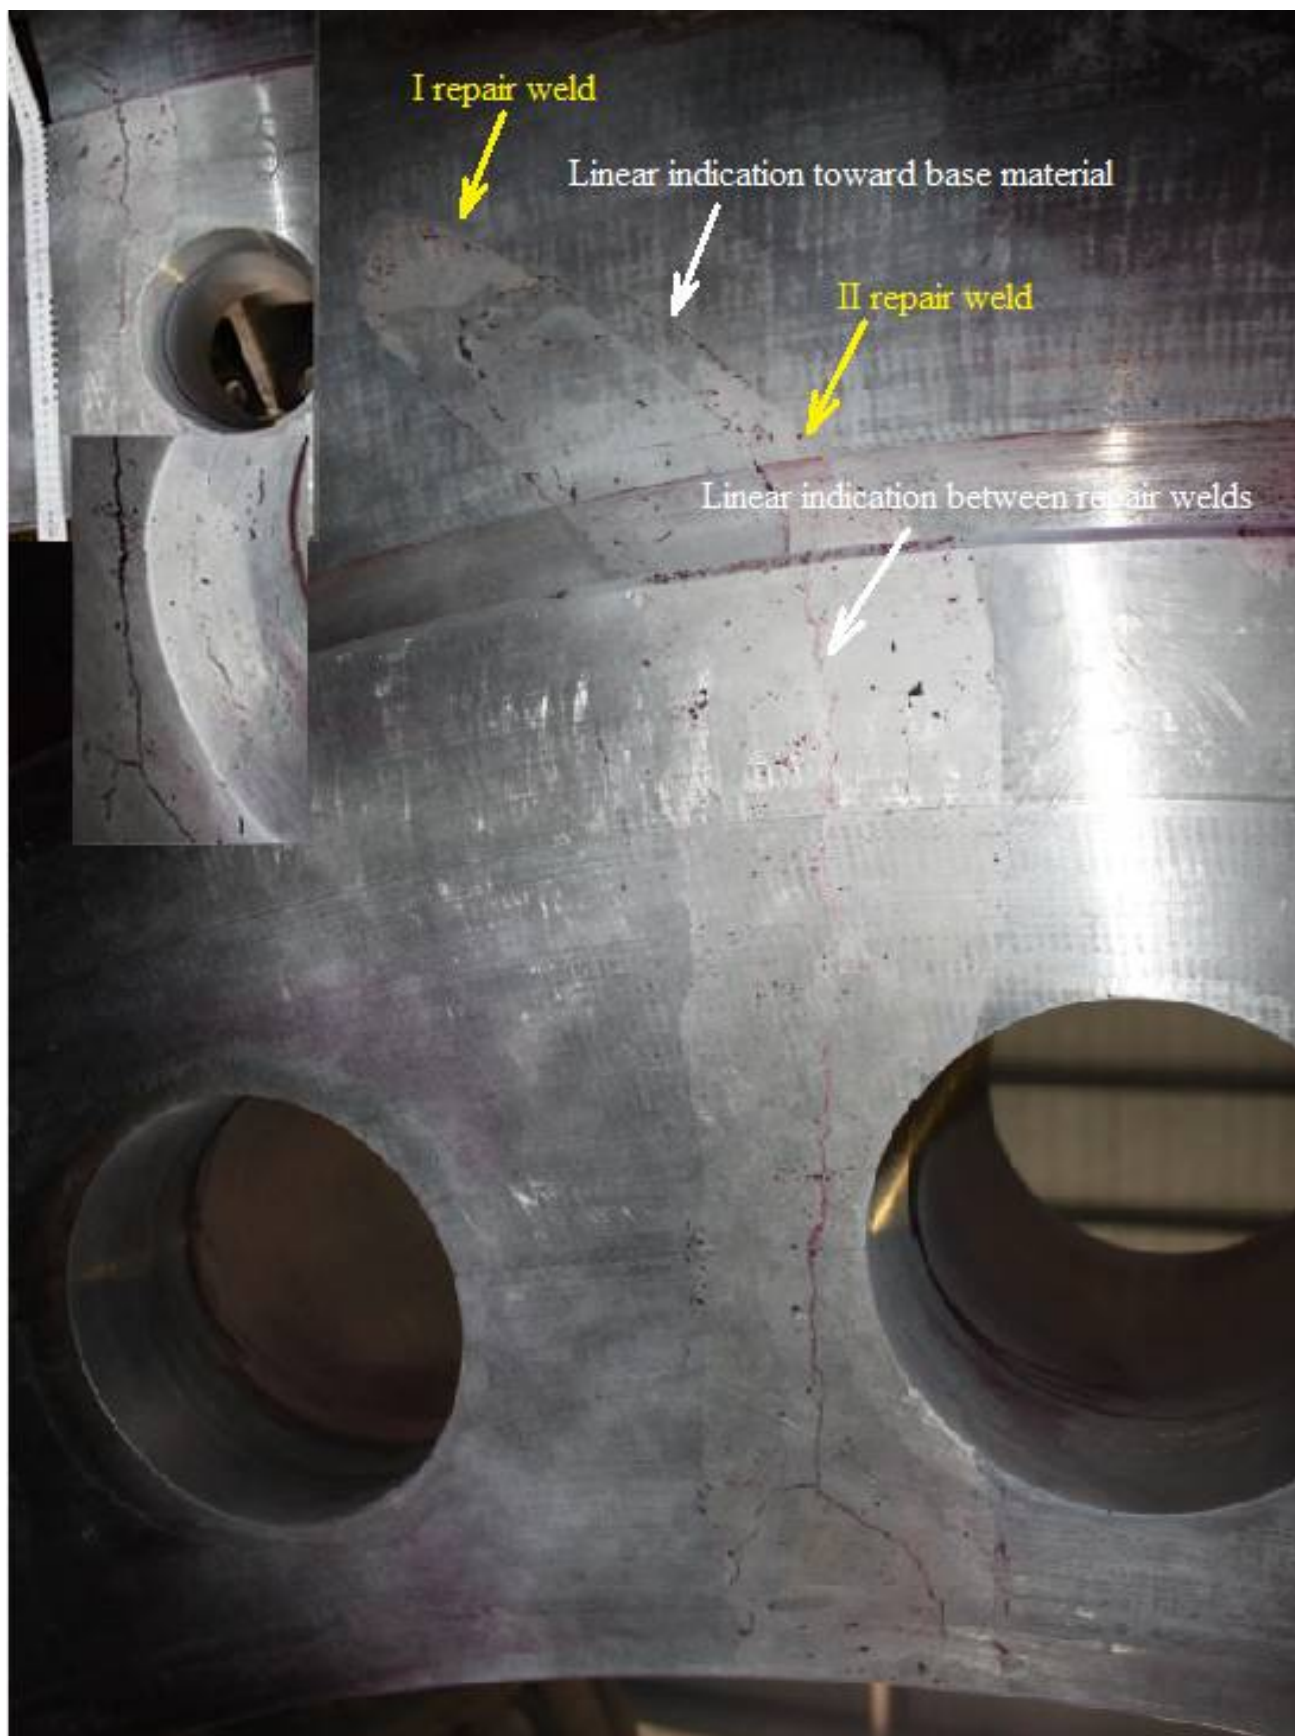
Cracks between the openings for bolts nr. 5 and 6 are detected in the area between weld metal and base material (in the heat-affected zone) and between two repair welded joints, that are carried out with different kinds of austenitic filler material, Fig. 4. Cracks between the openings for bolts nr. 29 and 30 are detected in the weld metal of the repair weld, in the transition area between the hub and the turbine shaft, and between the hub and the axial bearing disk carrier, Figs. 5 and 6.

Figure 4. Cracks in the area between weld metal and base material of the hub; between two repair welds; and between openings for bolts nr. 5 and 6.

The repair welding/surface welding technology refers to works carried out during the repair of cast part of the generator rotor hub, at which it was necessary to perform welding/surface welding in zones where cracks are detected, depthwise and at the internal surface of the opening for bolt nr.5. The welding/surface welding technology defines all activities that are supposed to be carried out before, during and after the welding/surface welding. Cracks detected by visual, penetrant and magnetic particle tests are removed by grinding, Fig. 9.

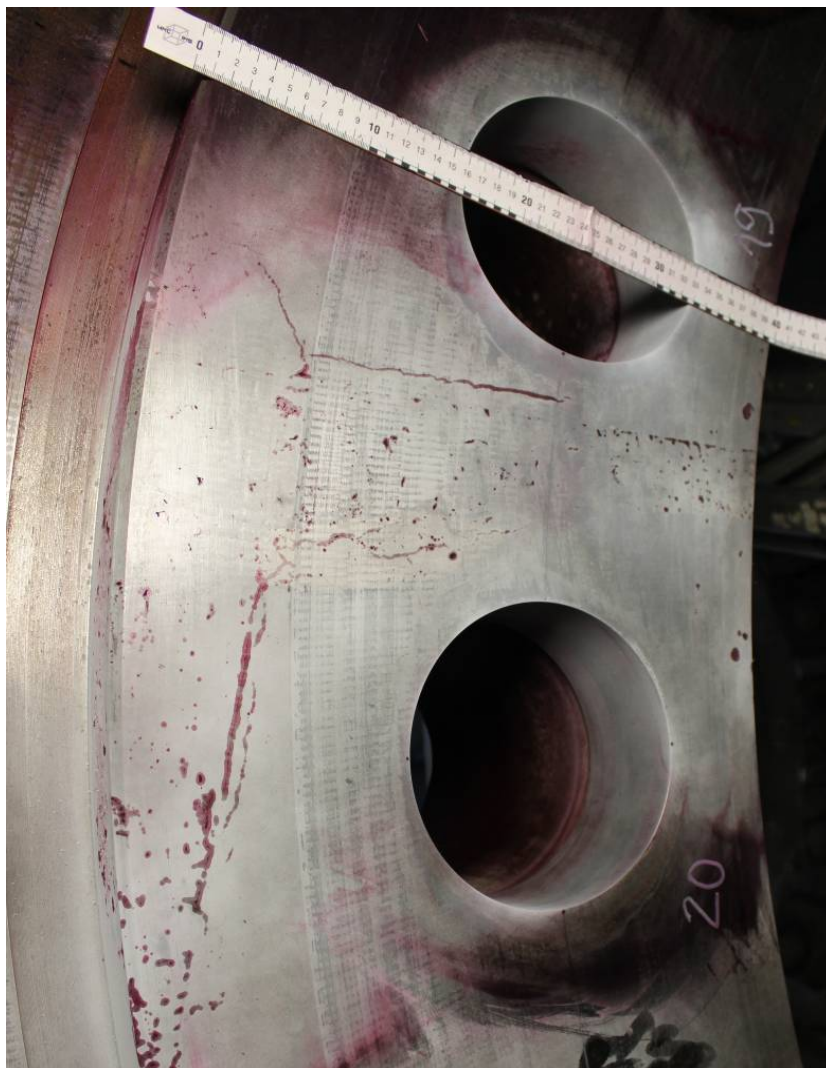
Figure 5. Cracks in the area of the repair weld (between openings for bolts nr. 19 and 20).

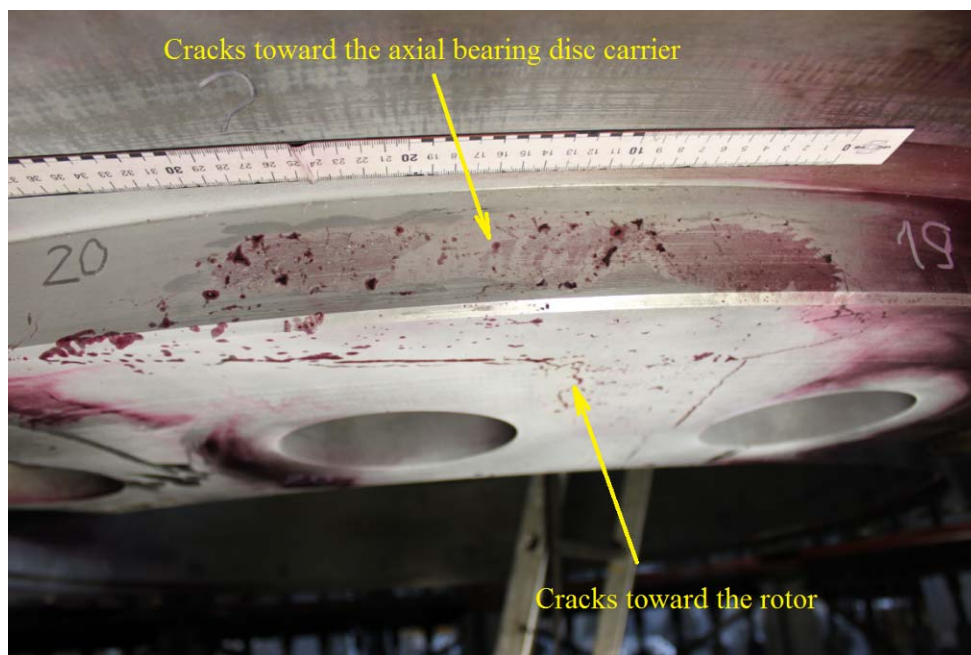
Figure 6. Cracks in the repair weld area between the hub and rotor shaft, and in the transition area from the hub toward the axial bearing (between openings for bolts nr. 19 and 20).

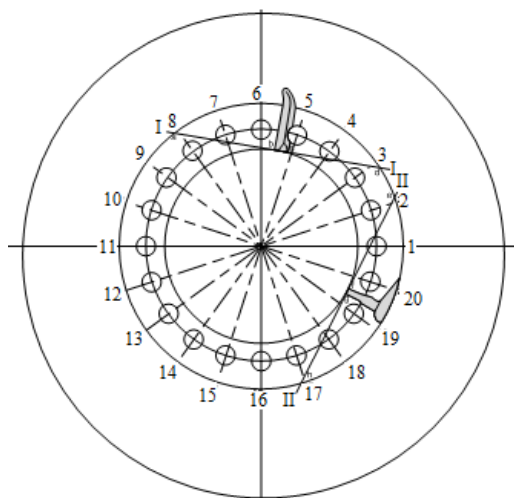
Figure 7. Planeness test for flange surface (view from below).

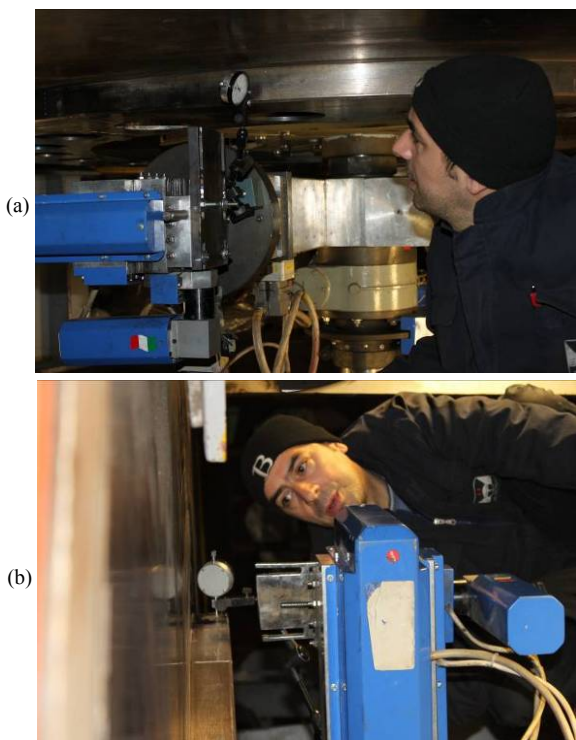
Figure 8. Planeness test for flange surface carried out by measure controller: a) view from below; b) side view.

Inspection of the surface condition regarding the deformations of the generator rotor hub (planeness test) is carried out before, during and after welding/surface welding, by positioning a 2 m long ruler tangentially with respect to the internal edge of the hub flange at many locations, and in areas where grinding was applied (positions I-I and II-II), presented in Fig. 7, while the planeness test carried out by measure controller is shown in Fig. 8. At measurement locations a, b, c and d for position I-I, as well as e, f, g and h for position II-II, the clearance is determined by measure controllers. Results of clearance measurement are presented in Table 7, /5/.

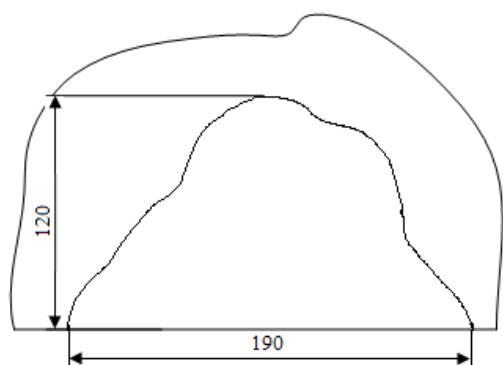
Figure 9. Appearance of the groove at location of deepest crack.

Before welding/surface welding, the grinded areas were preheated by gas flame at 120-150 °C. Butane is used for preheating, while IC thermometer is used for temperature control. After the deposition of the first weld layer, preheating was no longer necessary.
