## Analiza stanja vitalne čelične konstrukcije kabine rukovaoca rotornog bagera nakon havarije i sanacije

U radu je prikazana analiza stanja vitalne čelične konstrukcije kabine rukovaoca rotornog bagera DU 2, izrađene od cevi različitih prečnika i debljina lima, nakon havarije izazvane udarom kamena u poprečni nosač konstrukcije. Kamen se nalazio u otkopanom uglju jedne od kašika rotora bagera. Prilikom udara kamena poprečni nosač konstrukcije kabine rukovaoca se savio i popucali su zavareni spojevi između prirubnica na sredini poprečnog

## State Analysis of the Vital Steel Structure of the Bucket-wheel Reclaimer Operators Cabin After the Breakdown and the Rehabilitation

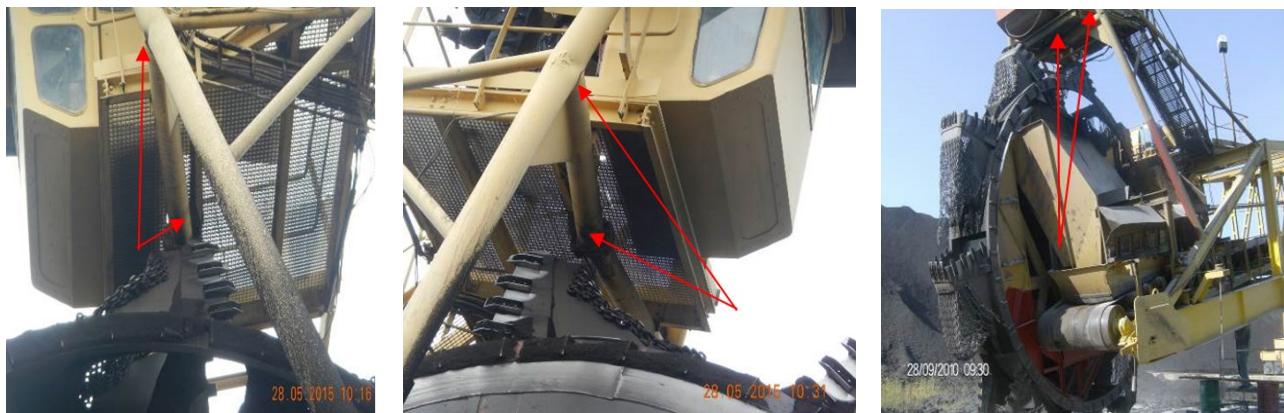
Slika 3. Oštećenja na poprečnom nosaču konstrukcije izazvana udarom kamena koji se nalazio u otkopanom uglju jedne od kašika rotora bagera

nosača i zavareni spojevi na mestima veze poprečnog nosača sa vertikalnim nosačima konstrukcije.

a) Desna strana konstrukcije, savijanje nosača i otkaz ZS

b) Savijanje poprečnog nosača i oštećenja ZS na prirubnici i vertikalnom stubu

c) Leva strana konstrukcije, savijanje nosača i otkazi ZS

Da bi se u potpunosti obezbedilo integritet noseće čelične konstrukcije kabine rukovaoca rotornog bagera DU2, u višegodišnjem periodu, potrebno je izvršiti zamenu oštećenog poprečnog nosača konstrukcije kabine rukovaoca bagera.

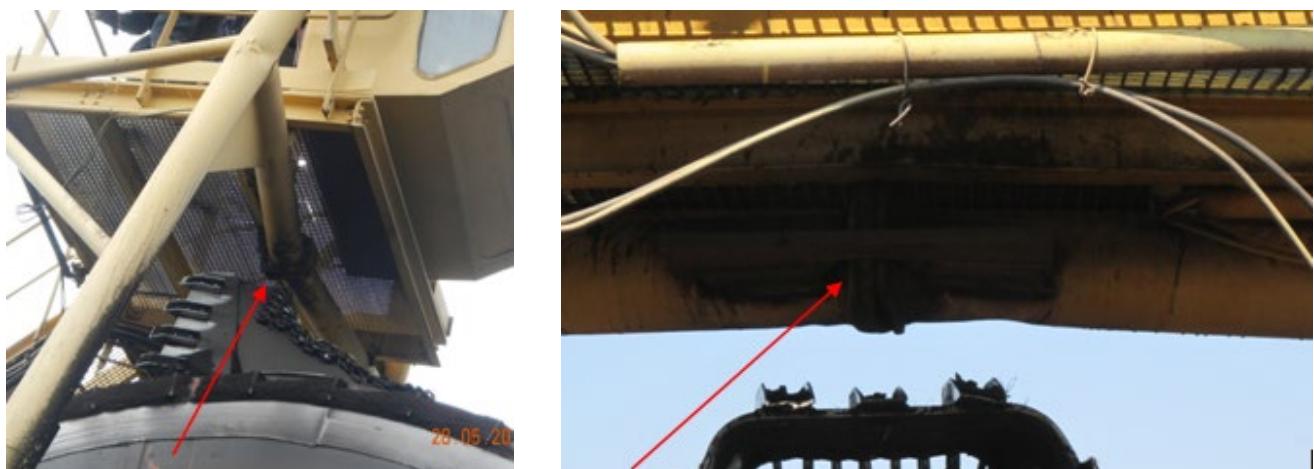
Slika 4. Prikaz sanacije središnjeg dela poprečnog nosača kabine rukovaoca bagera

a) Oštećenje poprečnog stuba pre sanacije

b) Sanacija ZS na prirubnicama poprečnog stuba

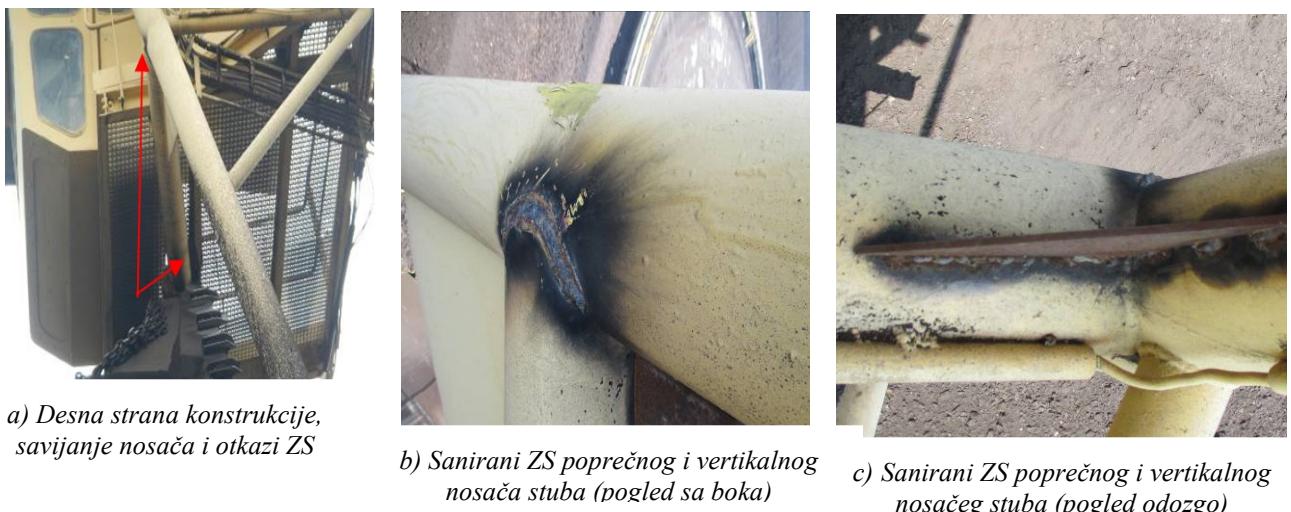
Slika 5. Prikaz sanacije ZS između poprečnog i vertikalnog nosačeg stuba kabine rukovaoca rotornog bagera (desna strana)

a) Desna strana konstrukcije, savijanje nosača i otkazi ZS

b) Sanirani ZS poprečnog i vertikalnog nosača stuba (pogled sa boka)

c) Sanirani ZS poprečnog i vertikalnog nosačeg stuba (pogled odozgo)

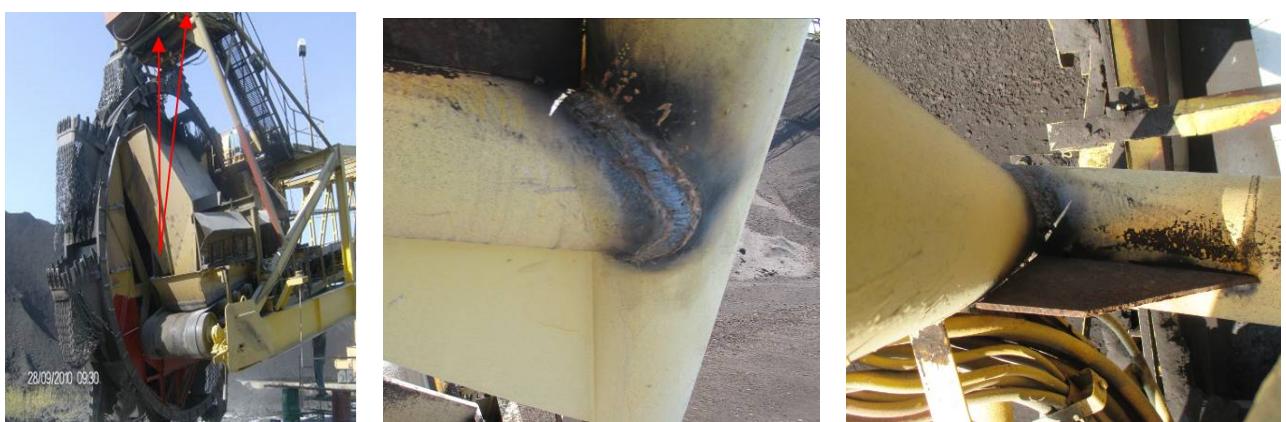
Slika 6. Prikaz sanacije ZS između poprečnog i vertikalnog nosačeg stuba kabine rukovaoca rotornog bagera (leva strana)

a) Leva strana konstrukcije, savijanje nosača i otkazi ZS

b) Sanirani ZS poprečnog i vertikalnog nosačeg stuba (pogled bočno)

c) Sanirani ZS poprečnog i vertikalnog nosećeg stuba (pogled odozgo)

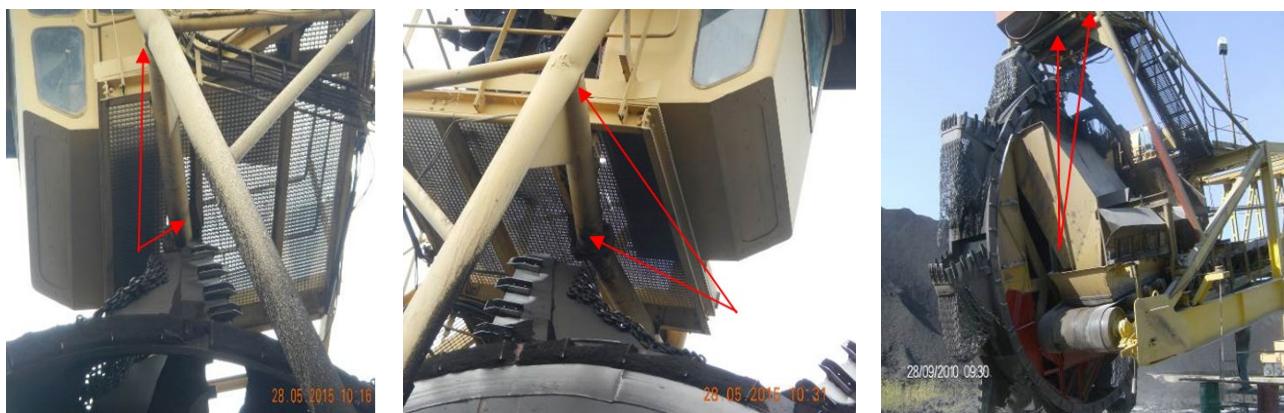
Figure 3: Damages at the horizontal support of the structure caused by the impact of the rock located in the excavated coal at one of the buckets

In this paper the state analysis of the vital steel structure of the bucket-wheel reclaimer DU2 operators' cabin, made of pipes of various diameters and thicknesses, after the breakdown caused by a rock that hit the horizontal support of the structure is presented. The rock was located in the excavated coal within a bucket of the bucket-wheel reclaimer. The horizontal support of the operators' cabin structure has bent and welded joints between flanges at the

middle of the horizontal support, as well as welded joints at bonds of the horizontal support with vertical supports of the structure, have cracked due to the impact of the rock.

a) Right side of the structure, bent support and damaged welded joints

b) Bent horizontal support and damaged welded joints at the flange and vertical beam

c) Right side of the structure, bent support and damaged welded joints

In order to fully ensure the integrity of the support steel structure of the bucket-wheel reclaimer DU2 operators' cabin as a whole during a long period of time, it is necessary

to replace the damaged horizontal support of the operators' cabin steel structure.

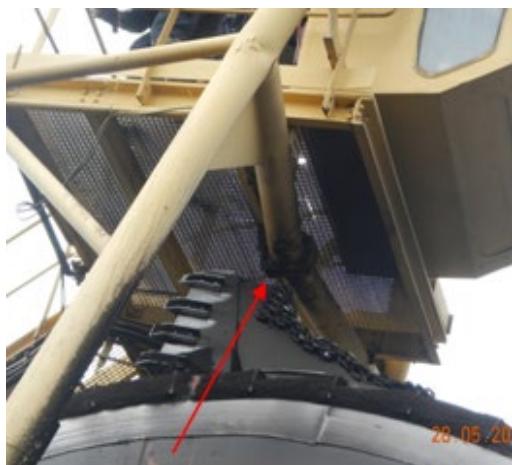
a) Damage at the horizontal support before repair

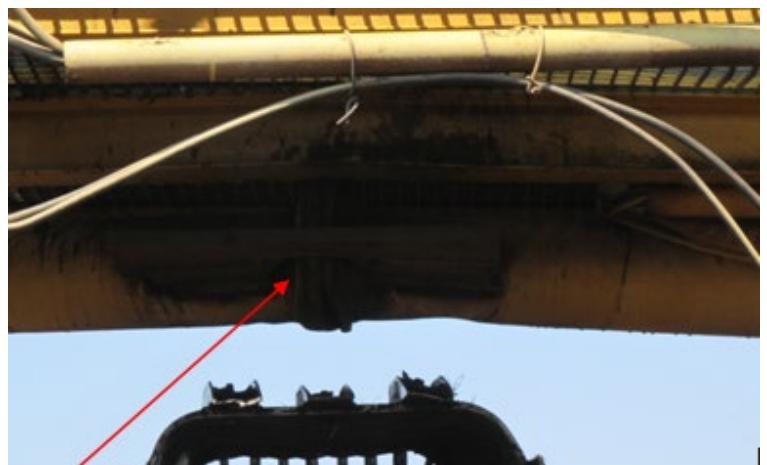
Figure 4: Appearance of repair of the middle section of the operators' cabin horizontal support

b) Repair of welded joints at the flanges of the horizontal beam

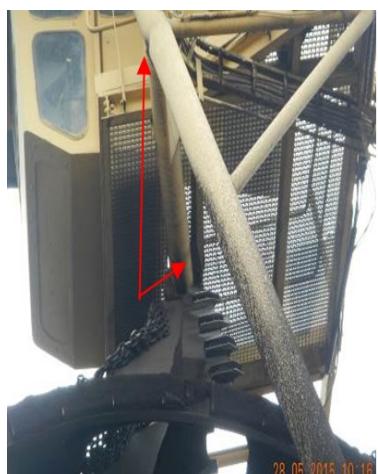
a) Right side of the structure, bent support and damaged welded joints

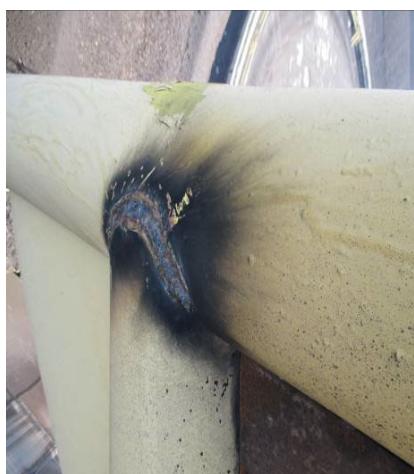
b) Repaired welded joint between the horizontal and vertical support (view from the side)

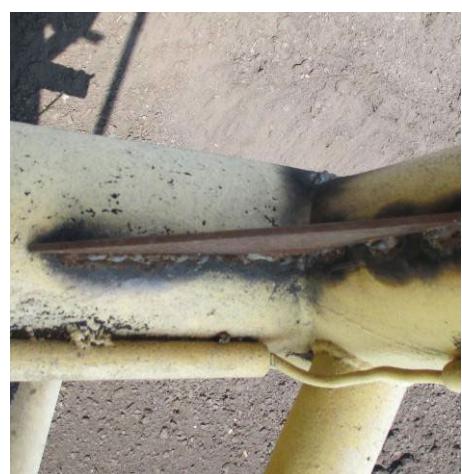
Figure 5: Appearance of the repaired welded joint between the horizontal and vertical support of the operators' cabin (right side)

c) Repaired welded joint between the horizontal and vertical support (view from above)

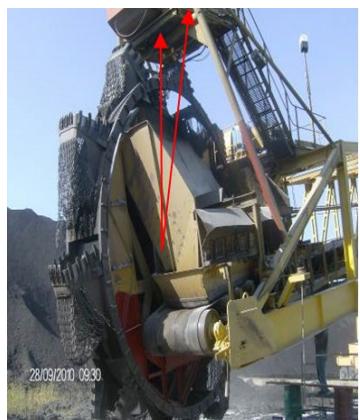
a) Left side of the structure, bent support and damaged welded joints

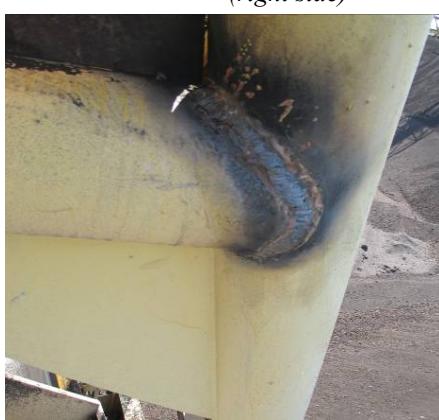
b) Repaired welded joint between the horizontal and vertical support (view from the side)

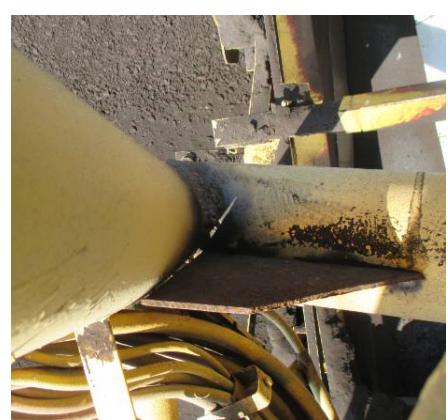
Figure 6. Appearance of the repaired welded joint between the horizontal and vertical support of the operators' cabin (left side)

c) Repaired welded joint between the horizontal and vertical support (view from above)
