Dejan Momčilović<sup>1</sup>, Nenad Hut<sup>1</sup>, Ljubica Milović<sup>2</sup>, Ivana Atanasovska<sup>3</sup>

## FAILURE ANALYSIS OF CHAIN BRACKET ANALIZA LOMA SPOJNICE LANCA

Original scientific paper  
UDC: 621.867.3.016 : 539.4  
Paper received: 10.07.2011

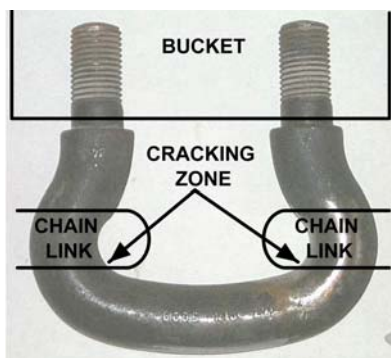
This paper describes failure analysis of chain brackets, Fig. 1, used for joining segments of chain as well as for attaching brackets for cement transport, from a domestic cement plant. After detection of cracks on in-service chain

brackets, all unused chain brackets are tested by magnetic particle method. On several new chain brackets, cracks are found at the same zone as in-service brackets, Fig. 1. This has raised the question regarding the hidden production of flaws and the remedy for this type of cracks. These types of cracks are characteristic for one shipment only and another bracket shipment is replaced due to wear.

The contact zone between chain link and bracket, Fig. 1, is one of the most stressed zones in this elevator system,

Figure 1. Chain bracket with schematic connection of bucket with chain links.

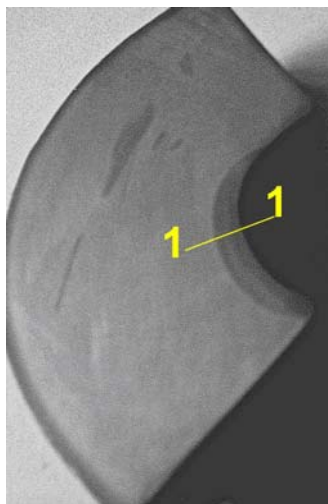
and in that zone fracture has occurred, Fig. 2. The fracture surface indicates that the bracket operated at the unidirectional bending at low nominal stress. The chain bracket is produced by forging with small flash line i.e. excess metal that extends out from the body of bracket. Sulphur print, Fig. 3 reveals that carburized depth is approximately 2 mm, in chain contact zone, with hardness profile shown in Fig. 4.

Figure 3. Carburized zone of chain bracket.

Chain bracket are produced from bars, hot bended before forging, which leads to wrinkling of material in zone 1-1, in Fig. 3. After cooling, small initial cracks, as a result of wrinkling, remain on surface. Subsequent forging, with distinct flash, and thermal cycles as a result of heat treatment only help propagation of those initial cracks. The storage of chain brackets during shipment disables moisture and oxidation. The environment where the chain bucket elevator is in-service is very dry, because cement is a highly hygroscopic material, so it is plausible to conclude that the oxide found in Fig. 8, is from production. The fact that operating stress is low combined to the high impact toughness of forging, has prevented the catastrophic failure of the chain bucket elevator.

The origin of cracks on new and in-service chain brackets is found in the production process, as a result of wrinkling of the material during hot bending. Simply a low-cost operation, after hot bending, the grinding in zone of further carburization could prevent the occurrence of cracks in chain brackets.

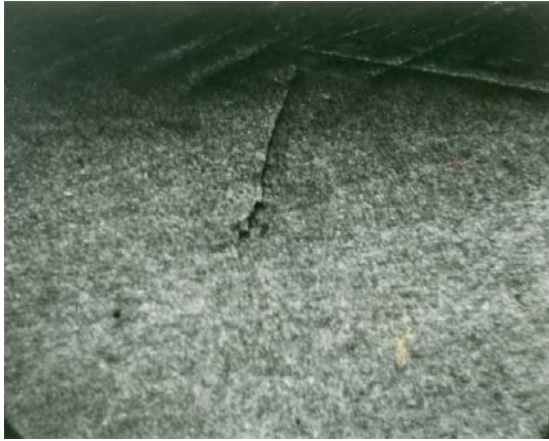
SEM analysis, from crack presented in Fig. 5, shows significant presence of oxide on crack surfaces, Fig. 8. Fatigue striations are shown in Fig. 9.

Figure 5. Carburized zone with the crack, hardness values between 600 and 700 HV.

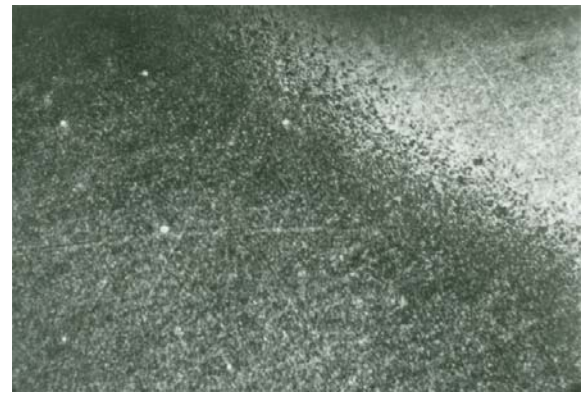
Figure 6. Transition zone, hardness values between 300 and 600 HV.

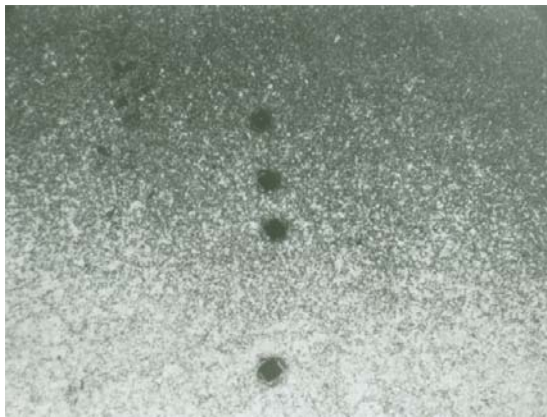
Figure 7. Fine grain ferrite-pearlite microstructure of chain bracket forging, average hardness value 220 HV.
