ANALYSIS OF THE STEAM LINE DAMAGES

**Vujadin Aleksić¹, Dejan Momčilović², Bojana Aleksić³, Ljubica Milović⁴,
Aleksandar Sedmak⁵**

Summary: *The methodological approach to the analysis of damage to determine the cause of failure and to repair the damage has been shown using the example of leakage and damage of a steam line for live-steam in thermal power plants and heating plants. The access presented may be applied to similar structures, and its application in preventive maintenance contributes to extension of the exploitation life of the steam lines.*

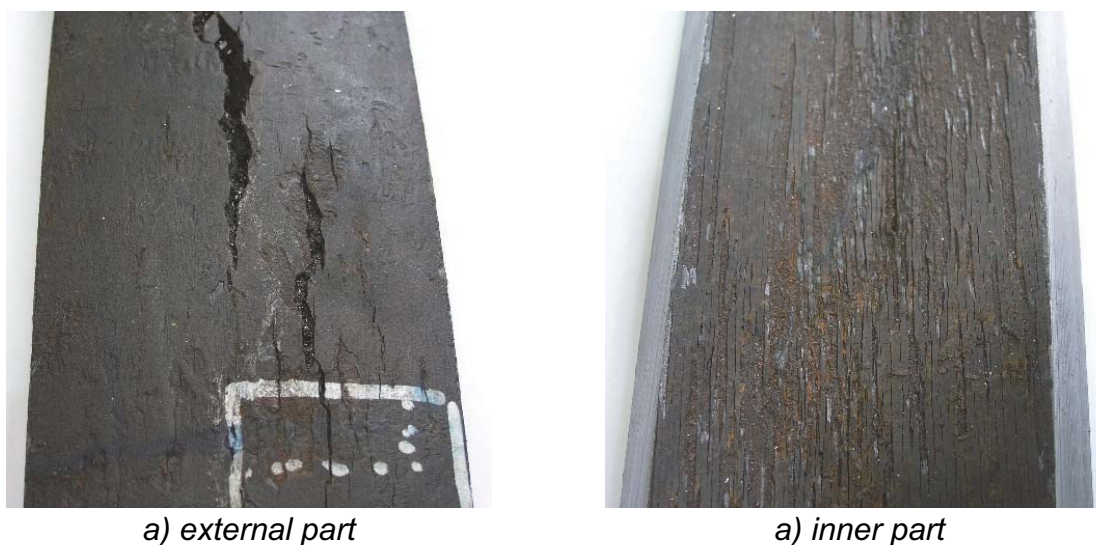
Fig. 1 *The Appearance of the Damaged Part of the Steam Line*

The structure of the steam line is exposed to the low-cycle fatigue loads. Such a load caused fatigue fracture and leakage of the steam line for live steam at RA 10, TPP Kolubara A, Tab. 1, which was determined by visual examination, Fig. 1.

The parts of the steam line in front of and behind the damaged part were tested using the NDT methods, Fig.1. The results showed that there were no damages on tested parts of the steam line.

The cause of leakage is the inhomogeneity of the material and a greater number of hours in operation than prescribed, and the result is creep of the base metal, leakage and failure of the steam line.

In order to prevent such phenomena, it is necessary to have a system of preventive maintenance and keep accurate records of all actions on the steam line, as well as to keep records on the quality of the materials built-in at the beginning and during exploitation of the steam line, respecting the terms of regular and emergency inspection prescribed by the Regulations.

It is necessary to estimate the exploitation life of the steam line on the undamaged part of the steam line, based on reliably established quality of the materials built-into steam line, the methods of non-destructive testing (NDT), including endoscopy, in correlation with the technique of risk-based inspection (RBI) [4, 6].

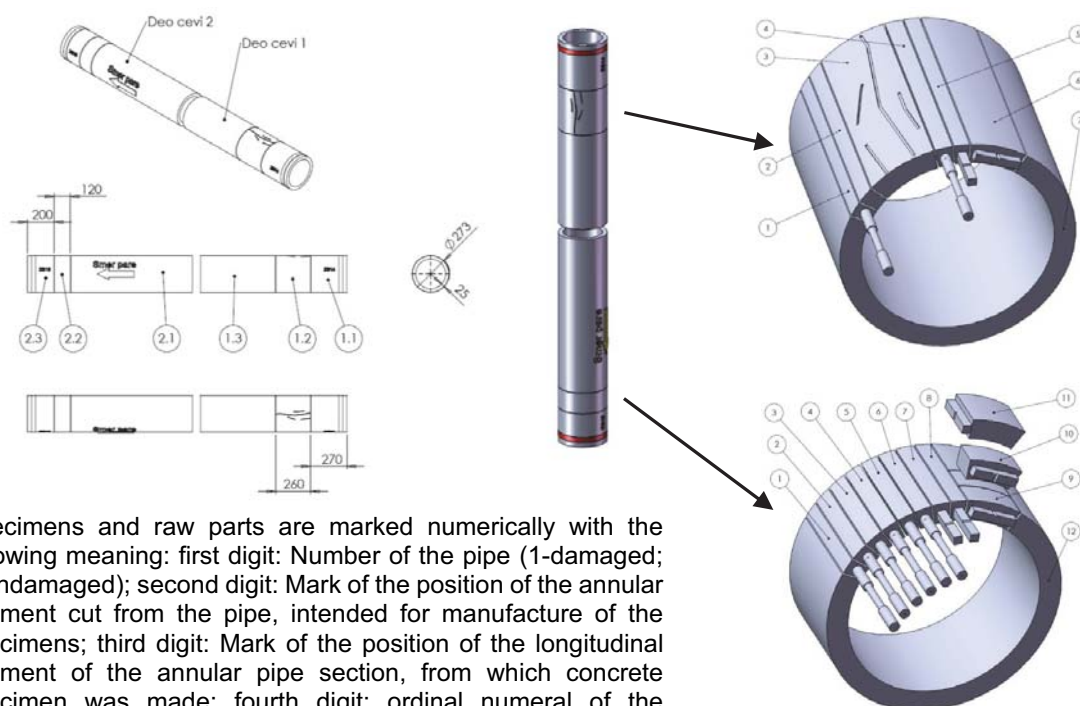
Fig. 2 Positions of Annular Segments and Test Specimens

In order to analyze the damage and determine the cause of leakage of the steam line for live steam, line RA 10, TPP Kolubara A, two parts of the pipe $\varnothing 273 \times 25$ mm, sampled from the same pipe of the leaking steam line, were submitted for examination. Namely, the pipe part with damage 1080 mm-long (1) and the pipe part without damage approx. 1260 mm-long (2), Fig. 2, were submitted.

Specimens and raw parts are marked numerically with the following meaning: first digit: Number of the pipe (1-damaged; 2-undamaged); second digit: Mark of the position of the annular segment cut from the pipe, intended for manufacture of the specimens; third digit: Mark of the position of the longitudinal segment of the annular pipe section, from which concrete specimen was made; fourth digit: ordinal numeral of the specimen from the same section.

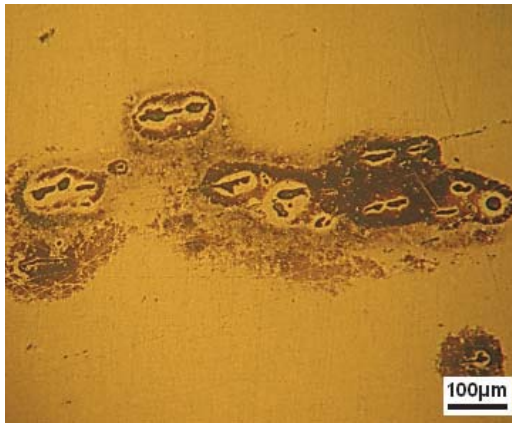
a)

Sample 1.2.3 (without etching), longitudinal section, coarse non-metallic inclusions of A3, B1 i D2 type.

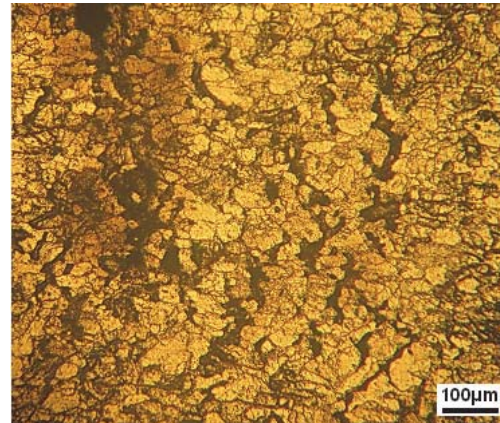
b)

Sample 1.2.3 (3% nital etched), transversal section, propagation of one of the macro cracks inside the pipe material

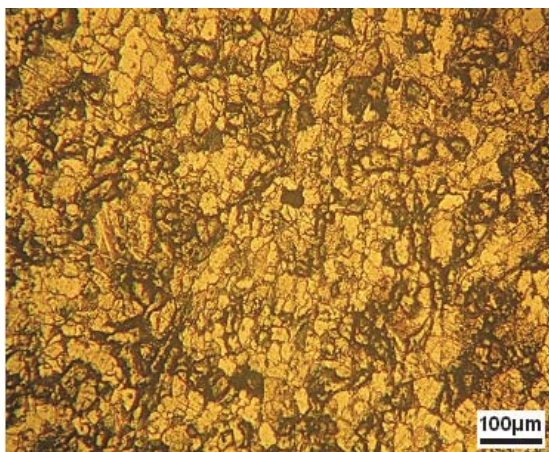
c)

Pipe sample 1.2.6 (3% nital etched), transversal section, predominantly ferritic microstructure in the pipe cross section

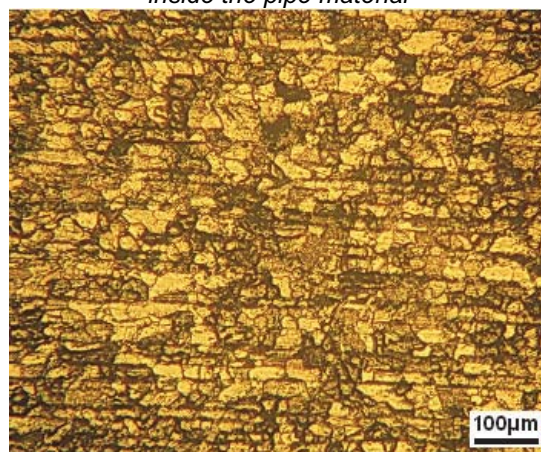
d)

Pipe sample 2.2.9 (3% nital etched), longitudinal section, predominantly ferritic, finely stripped microstructure in longitudinal section of the pipe.
