**B. Folic<sup>1</sup>, A. Liolios<sup>2</sup>, M. Ćosić<sup>3</sup>, and R. Folic<sup>4</sup>**

**Key words:** *Prestressed and Reinforced Concrete Framed Structures IMS, Seismic Strengthening System, Soil Pile Structure Interaction, Earthquake Resistant Structures.*

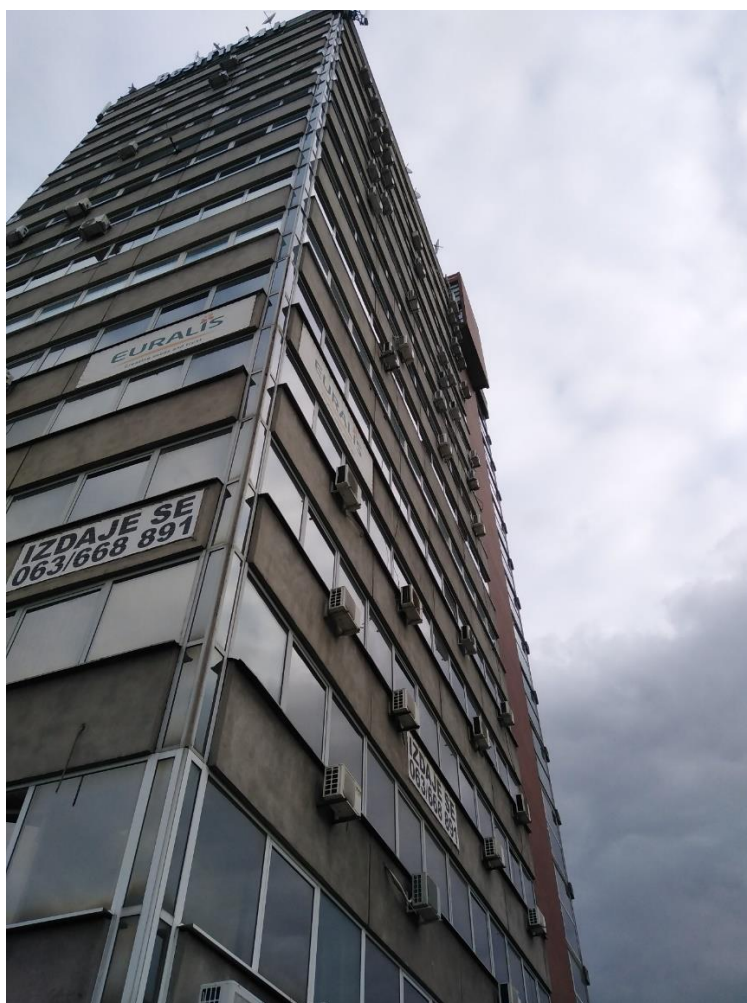
**Figure 1. The appearance of the Agrovojvodina building viewed from the first floor to the top. On the right, longer side is the Oslobođenje Boulevard, and on the left, transversal side is Car Lazar Boulevard**

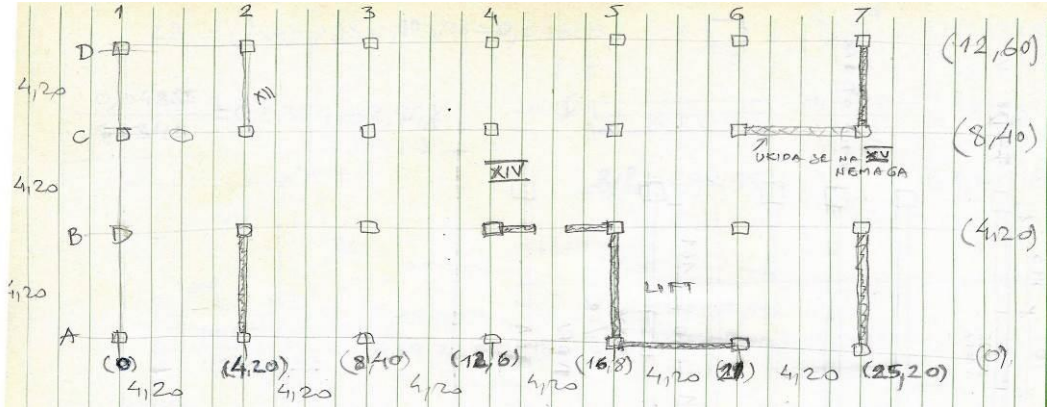
**Figure 2.** Ground floor plan (date design, April 1968). In reality, in the axis C/1-2 there is a bearing wall with an opening, but the working plan from the design does not have it, so it is not drawn here either.

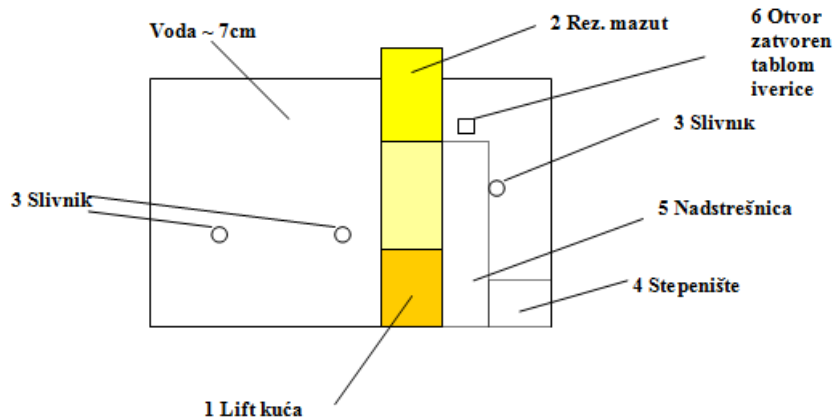
**Figure 4.** Plan of the roof and roof terrace of the AV tower. 1 Elevator equipment room. 2 Heating oil tank. 3 Drain. 4 Staircase. 5 Overhang. 6 Opening covered with plywood panel. Average water depth cca 10-11cm. Smaller roof terrace is in the right hand side of the image. Drawing is not drawn to scale.

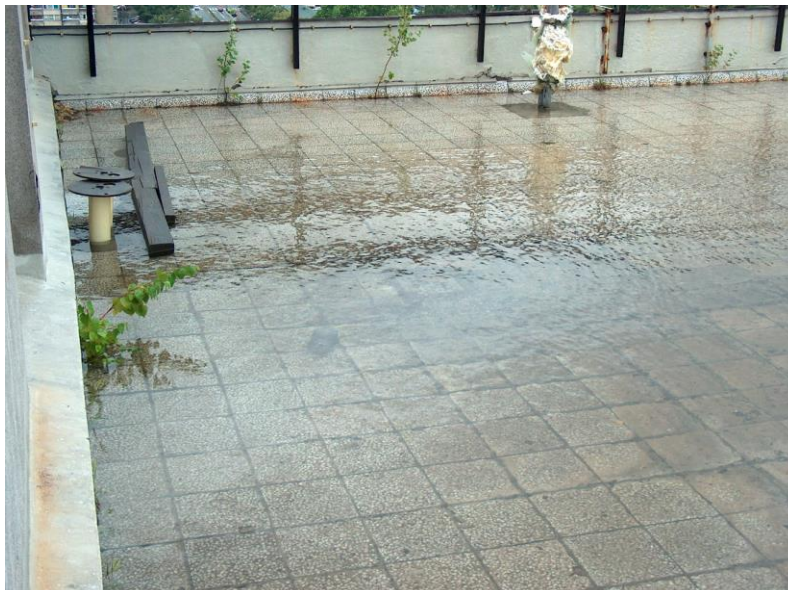
**Figure 5.** A view of the flooded roof terrace and unplanned roof plants near the attics. July 2004.

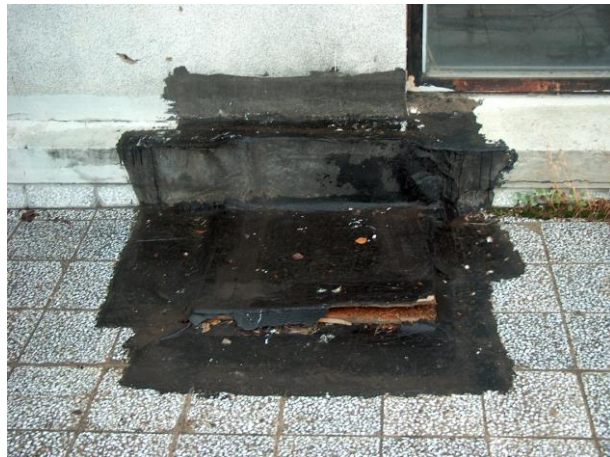
**Figure 7.** Opening on the roof closed off with the plywood panel. Waterproofing damaged in one part. July 2004.

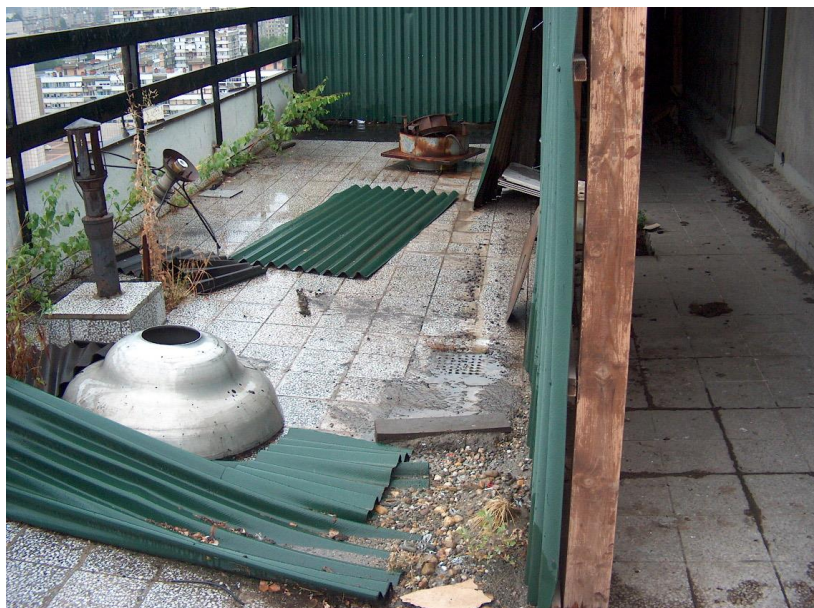
**Figure 8.** A view of a smaller roof terrace and a drain. July 2004.

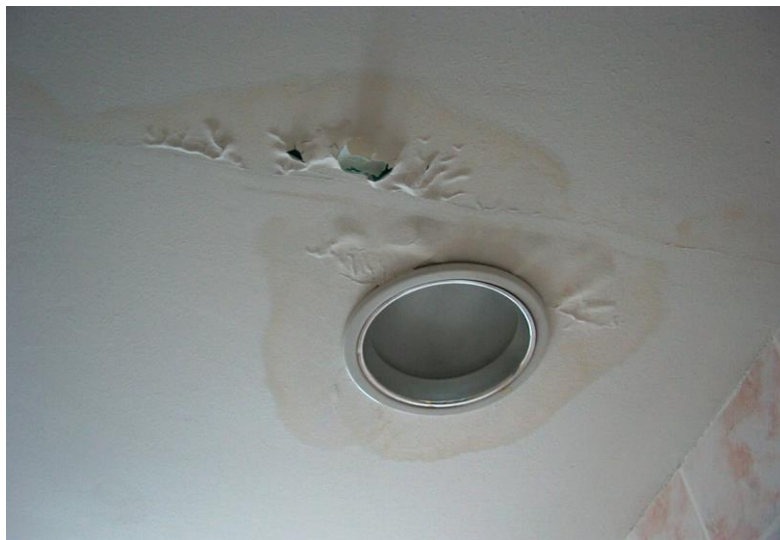
**Figure 10.** Leaking of the ceiling around the lighting fixture. July 2004.

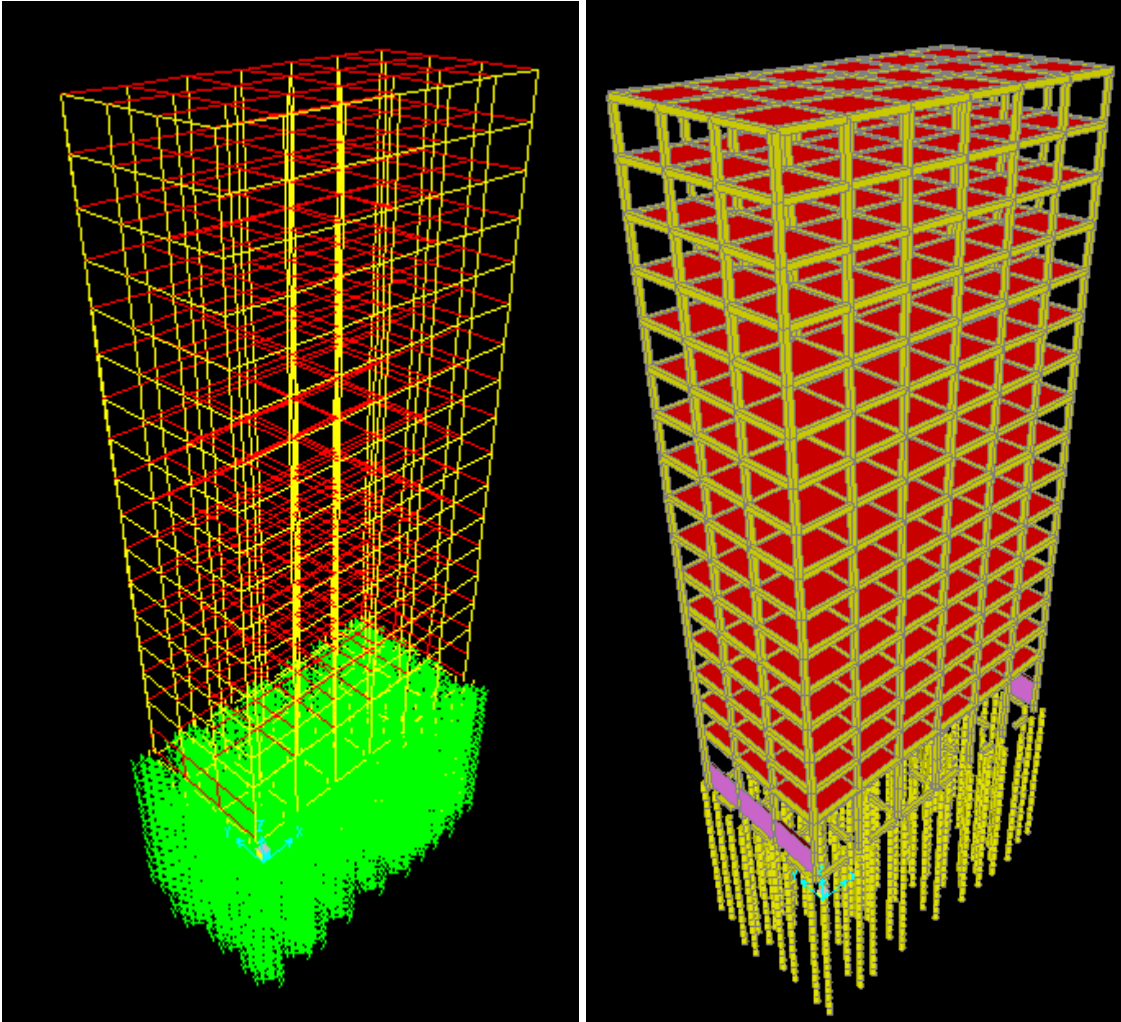
**Figure 11.** Simplified model of AV tower.

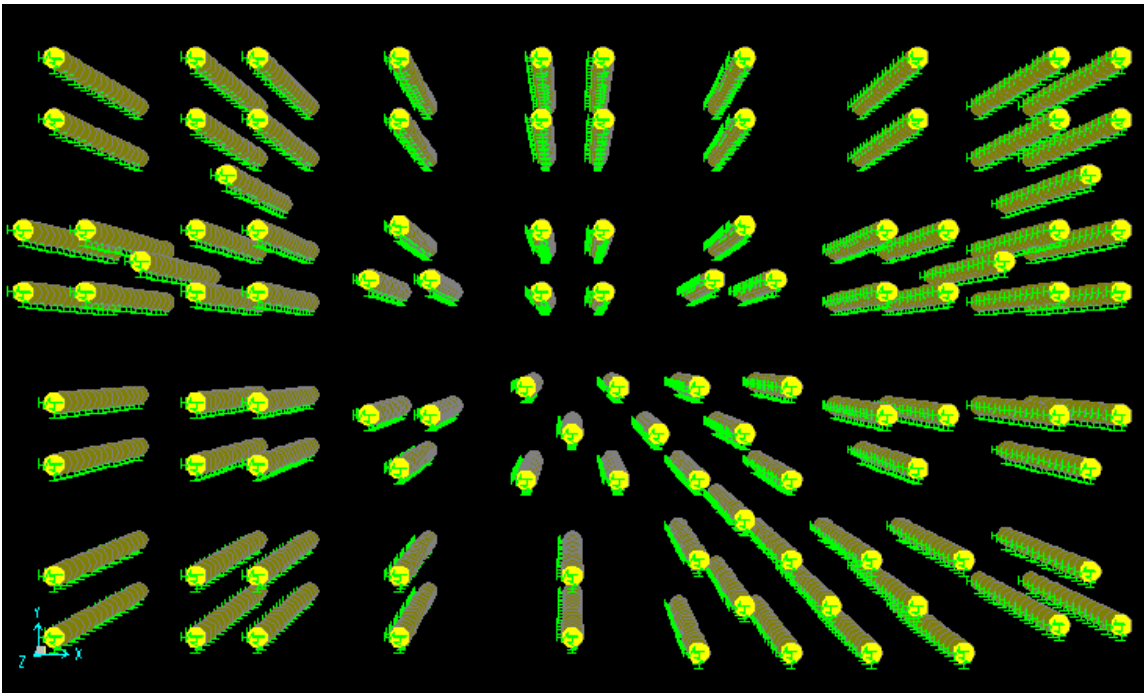
**Figure13.** 3D model of AV tower piles and elastic supports. Top view of the piles, from the ground surface (extrude view).
