## Analiza trenutnog stanja i ocena integriteta cevovoda na hidroelektrani Pirot

## Analysis of Current State and Integrity Evaluation of the Pipeline at Hydro Power Plant „PIROT“

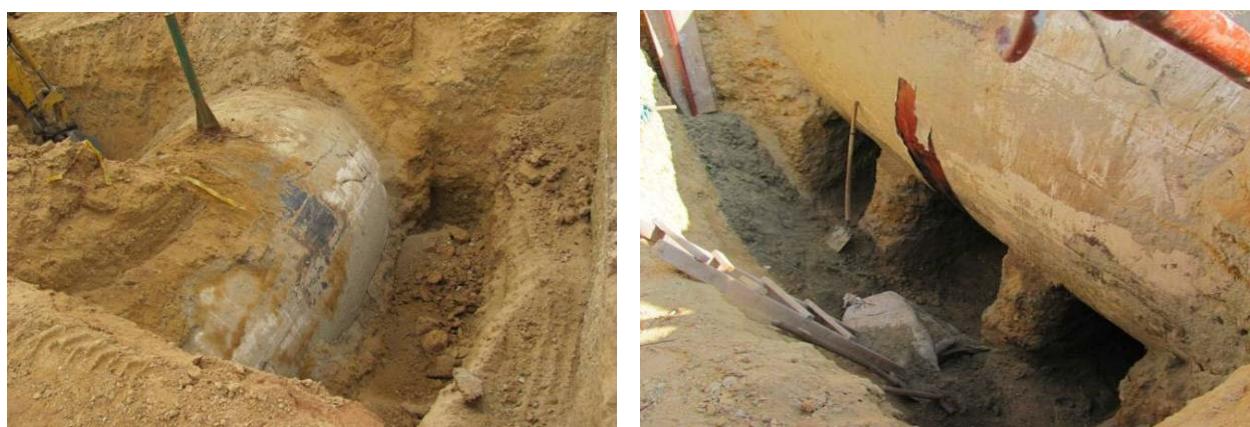
Sl.2. Prikaz otkopavanja cevovoda

Cevovod je projektovan i izgrađen bez ankernih blokova prelomima, što predstavlja retkost u svetu. U cilju analize trenutnog stanja i ocene integriteta cevovoda kao celine izvršena su ispitivanja metodama bez razaranja vitalnog sučeonog zavarenog spoja u zoni preloma na stacionaži – dužini cevovoda 1+263 m. Na tom delu cevovoda, prema projektnoj dokumentaciji, vertikalni prelom cevovoda iznosi 7,18<sup>0</sup>, a horizontalni 9,82<sup>0</sup> i prelaz cevi sa prečnika Ø 3500 mm na prečnik Ø 3340 mm. Na sl. 2 prikazano je otkopavanje, a na sl. 3 priprema cevovoda za predviđena ispitivanja.

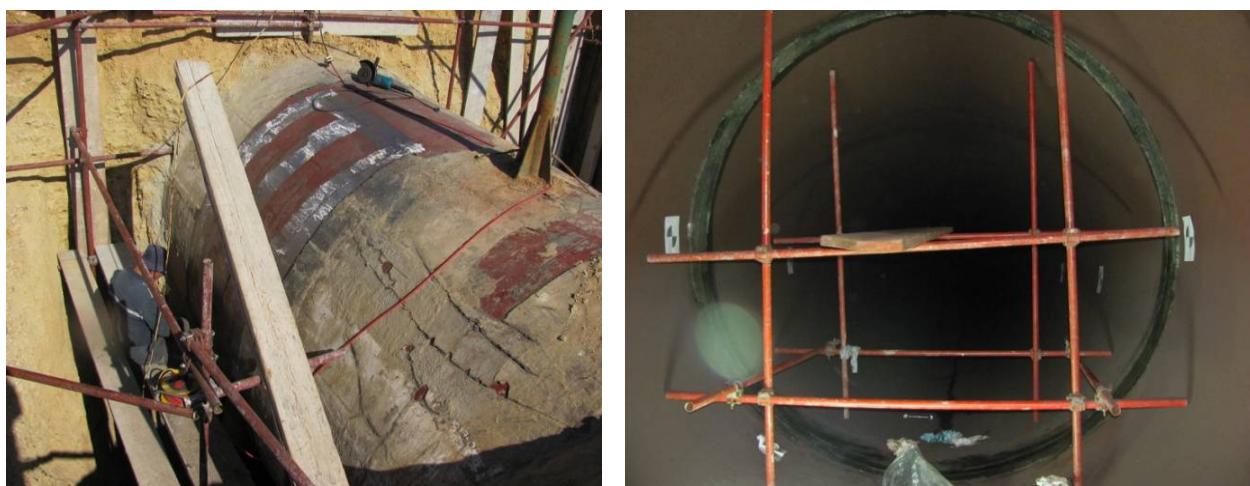
Sl.3. Prikaz pripreme brušenjem vitalnog zavarenog spoja na cevovodu radi ispitivanja

a) Priprema brušenjem spoljašnjeg dela

b) Priprema brušenjem unutrašnjeg dela

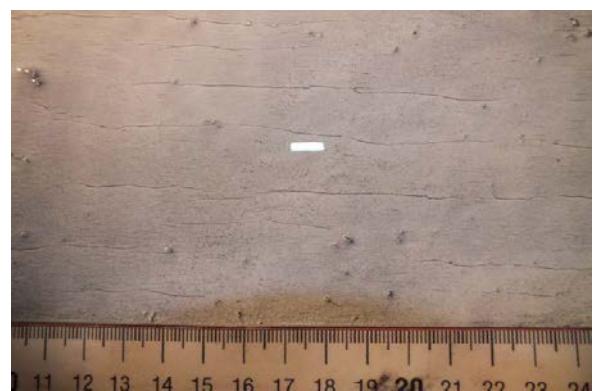
Sl.4. Prikaz jednog dela ispitane površine OM po obimu vitalnog sučeonog ZS u toj zoni cevovoda

Vizuelnim ispitivanjem [3] vitalnog sučeonog zavarenog spoja (ZS) u zoni najvećeg geometrijskog preloma cevovoda, u gornjoj zoni na spoljašnjoj strani cevovoda, utvrđene su površinske indikacije (prsline) u metalu šava (MŠ) na 5 mesta i veći broj prslina u zoni uticaja topote (ZUT) i u osnovnom materijalu (OM). Međutim, u donjoj zoni sa unutrašnje strane cevovoda utvrđene su površinske indikacije (prsline) samo u OM. Najveća utvrđena dobina prsline je veličine 2,5mm, a njihove duzine variraju pri čemu je najduža utvrđena u OM po obimu ZS i iznosi 540 mm, sl. 4.

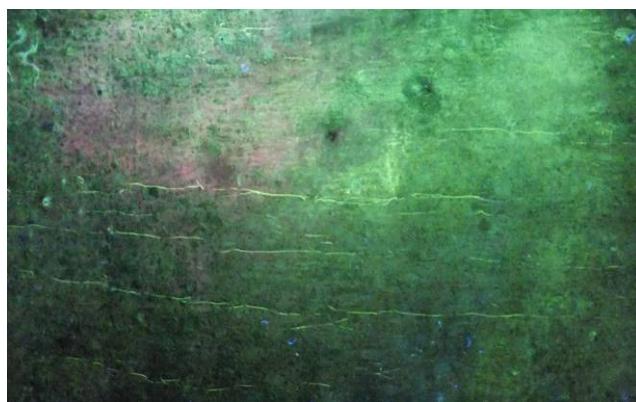
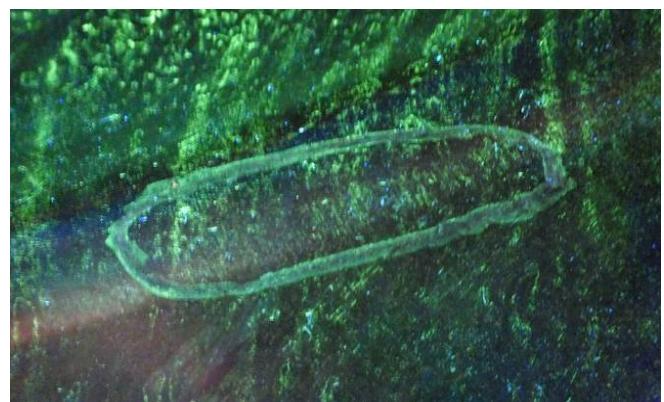
Sl.5. Prikaz ispitivanja magnetnim česticama jedne zone ZS sa spoljašnje strane cevovoda

Ispitivanja magnetnim česticama [4] ZS, sa spoljašnje i unutrašnje strane cevovoda, izvršena su da bi se proverilo

a) Prikaz površinskih prslina u OM

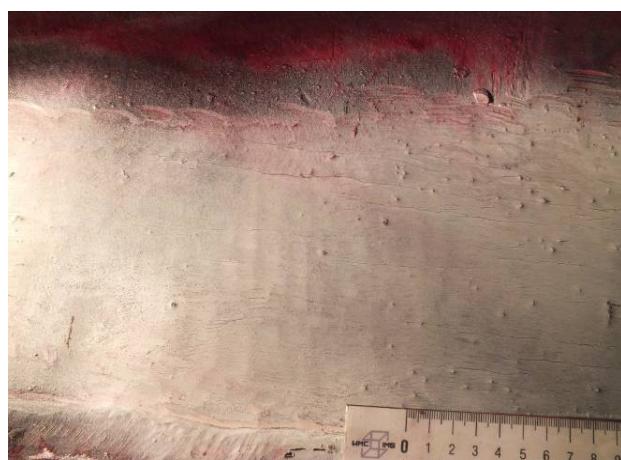
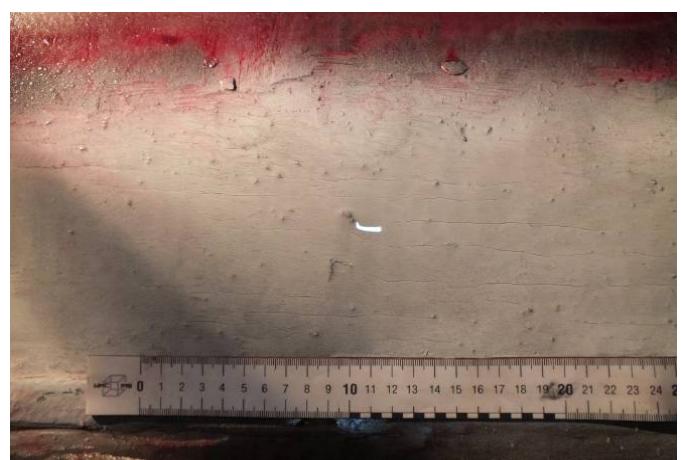
Sl.6. Prikaz ispitivanja penetrantima jedne zone ZS sa spoljašnje strane cevovoda

Ispitivanja penetrantima ZS [5], sa spoljašnje i unutrašnje strane cevovoda, izvršena su da bi se proverilo

a) Prikaz površinske prsline u ZUT

b) Prikaz površinskih prslina u OM

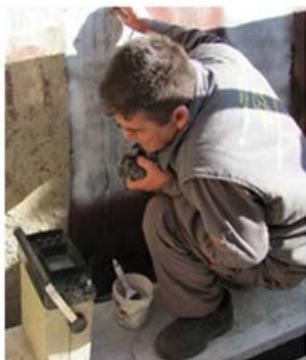
Sl.7. Prikaz ispitivanja UT dubina površinskih prslina u jednoj zoni ZS sa spoljašnje strane cevovoda

Ispitivanja ultrazvukom OM i ZS [6], sa spoljašnje i unutrašnje strane cevovoda, izvršena su da bi se utvrdile dubine površinskih prslina. Utvrđeno je da dubine prslina u

OM iznose od 1,5 mm do 2,5 mm, a dubine prslina u MŠ od 3,5 mm do 10,0 mm. Na sl. 7 prikazano je ispitivanje UT sučeonog ZS cevovoda i lokacija površinske prsline sa najvećom dubinom od 10 mm.

a) Prikaz UT ispitivanje ZS

b) Lokacija jedne od površinskih prslina dubine 2,5 mm u sučeonom ZS

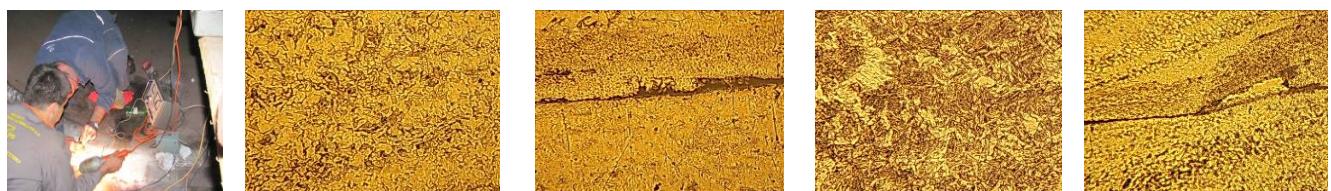
Sl.8. Karateristični rezultati metalografskog ispitivanja (metodom replika) mikrostruktura OM i ZS

Metalografskim ispitivanjem metodom replika [8], utvrđeno je mikrostruktorno stanje OM cevovoda. Ispitivanje je izvršeno na metalografskom mikroskopu marke "METAVAL" proizvođača "Carl Zeiss" iz Jene (Nemačka)

a) Uzimanje replika

b) Mikrostruktura OM

c) Jedna od prslina u OM

d) Mikrostruktura MŠ

e) Prsline u ZS

korišćenjem tehnike svetlog polja, nakon priprema ispitanih površina (čišćenje, odmašćivanje, niz operacija finog brušenja, završno poliranje, ispiranje, nagrizanje 4%-nim nitalom). Rezultatati ispitivanja su pokazali da je mikrostruktura površinskog sloja OM cevovoda feritno-perlitna sa prisutnim sitnim nemetalnim uključcima i produktima korozije, kao i makoprslinama dužina od 12 mm do 15 mm, a da je mikrostruktura MŠ krupnozrnasta feritno-perlitna sa prisutnim sitnim nemetalnim uključcima, produktima korozije i makoprslinama dužina od 30 mm do 35 mm. Karateristični rezultati ispitivanja prikazani su na sl. 8.

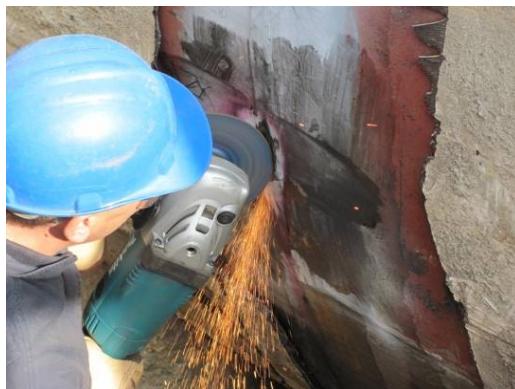
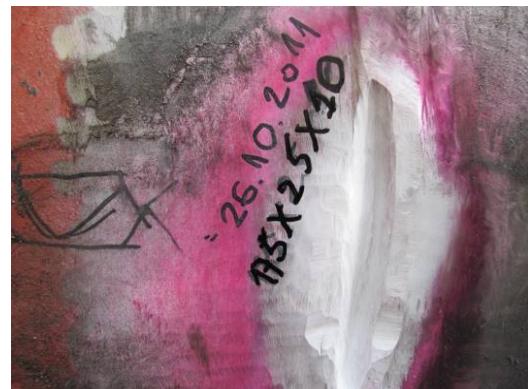
Sl.9. Priprema jedne od prsline u ZS sa spoljašnje strane cevovoda utvrđene ispitivanjima PT i UT

a) Prikaz pripreme prsline za sanaciju

Sl.9. Priprema jedne od prsline u ZS priprmljena za sanaciju

b) Jedna od prsline u ZS priprmljena za sanaciju

Površinske prsline u OM sanirane su finim brušenjem, a prsline u zonama vitalnog ZS reparaturnim zavarivanjem/navarivanjem primenom postupak 111 sa elektrodom EVB 50 (Elektrode Jesenice), klasifikovan prema standardu [9]. Hemijski sastav čistog metala šava elektrode dat je u tab. 3, a mehaničke osobine u tab. 4. Na sl. 9 prikazana je priprema prsline sa najvećom dužinom i dubinom za sanaciju. U toku i posle sanacije prslina u OM i vitalnom ZS cevovoda sprovedena su ispitivanja metodom VT i MT/PT.

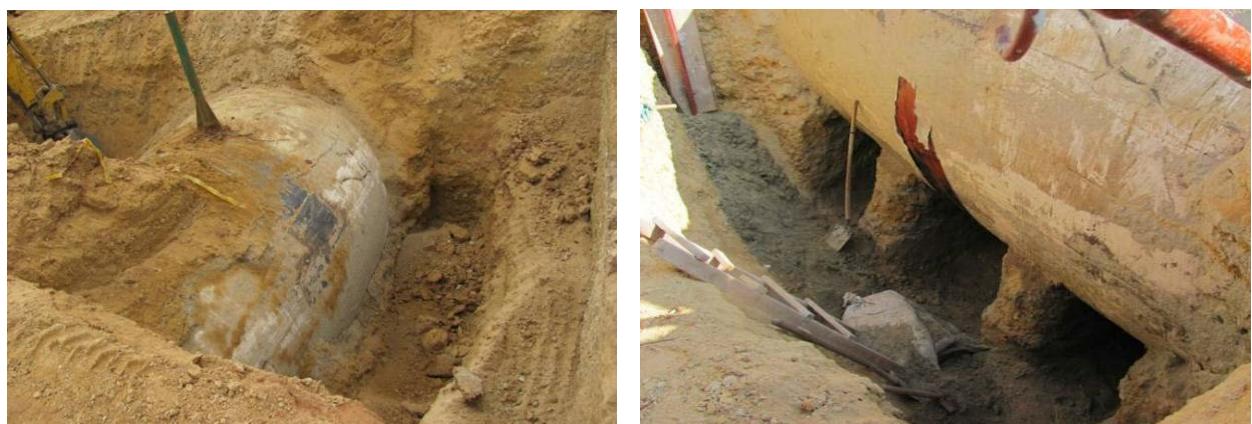
Fig. 2. Appearance of the uncovered pipeline segment

Pipeline has been designed and built without anchor blocks at curvatures, which is a rarity elsewhere. In order to perform the analysis of current state and integrity evaluation of the pipeline as a whole, non-destructive tests were performed on the vital butt-welded joint in the curvature area at chainage 1+263 m. In that area of the pipeline, according to the design documentation, the angle of the vertical curvature is 7,18°, while the angle of the horizontal curvature is 9,82°. The pipeline diameter changes from 3.500 mm to 3.340 mm. In figure 2 the uncovering of the pipeline segment is shown, while figure 3 shows the preparation of the pipeline segment for non-destructive testing.

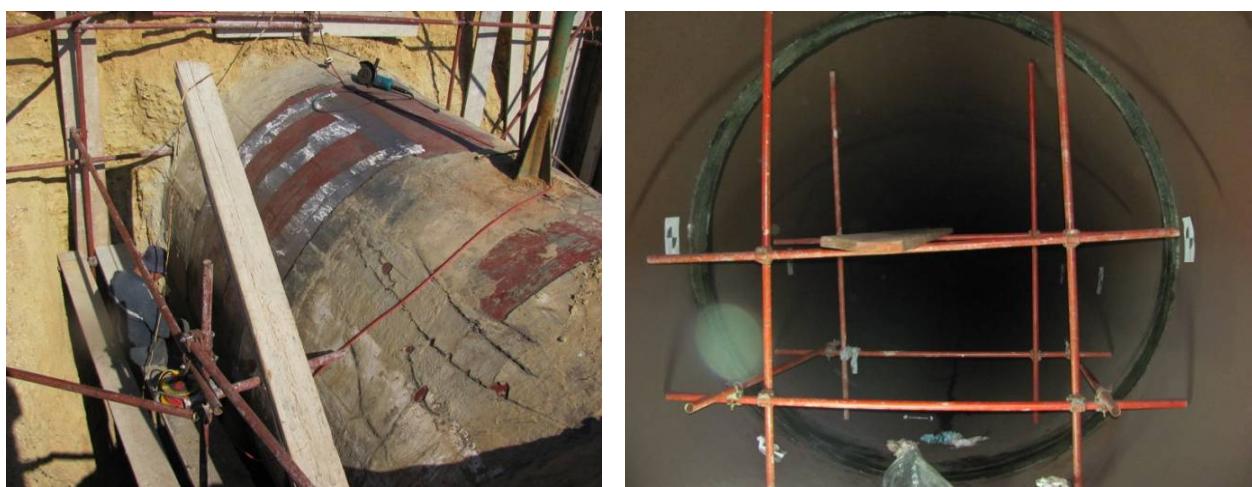
Figure 3. Appearance of preparation of the vital welded joint by grinding in order to perform NDT

a) Preparation of the external pipeline surface

b) Preparation of the internal pipeline surface

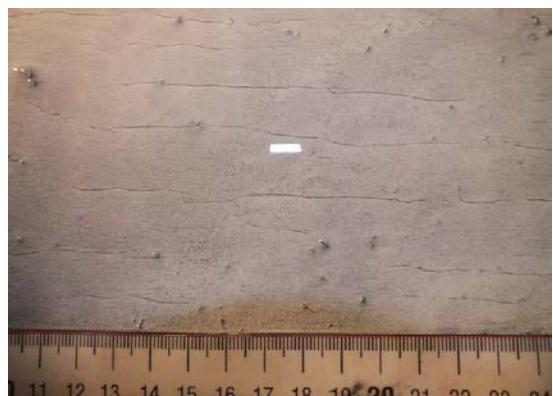
Figure 4. Appearance of a segment of the examined surface of parent material along the circumference of the vital butt-welded joint

Visual testing [3] was performed on the vital butt-welded joint, in the area of the most pronounced geometric curvature of the pipeline. Linear indications (cracks) were detected on the surface of weld metal at 5 locations in the upper zone of the external pipeline surface, along with a large number of cracks in the heat-affected zone and parent material. Nevertheless, in the lower zone of the internal pipeline surface the linear indications (cracks) were detected only at the surface of parent material. The deepest crack was 2,5 mm deep, while crack lengths vary. Length of the largest crack, located along the circumference of the parent material, was 540 mm (Figure 4).

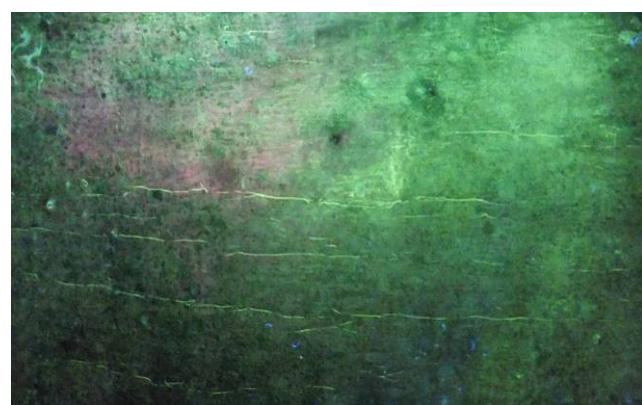
Figure 5. Appearance of magnetic particle testing performed on the welded joint at the external surface of the pipeline

Magnetic particle testing [4] was performed in the area of the welded joint, on the external and internal surface of the

a) Appearance of surface cracks on the surface of parent

b) Appearance of surface cracks the surface of weld metal material

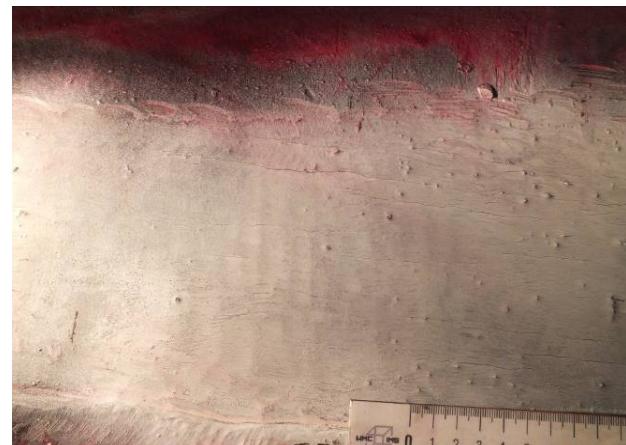
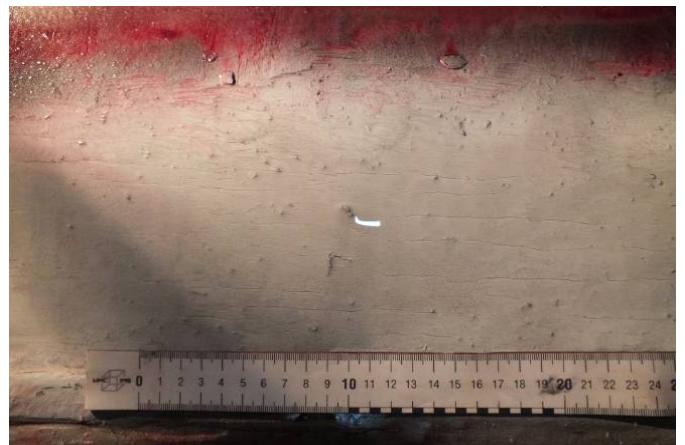
Figure 6. Appearance of magnetic particle testing performed on the welded joint at the external surface of the pipeline

Penetrant testing [5] was performed in the area of the welded joint, on the external and internal surface of the

pipeline, in order to determine locations of linear indications (cracks), figure 6.

a) Appearance of surface cracks on the surface of parent

b) Appearance of surface cracks the surface of weld metal material

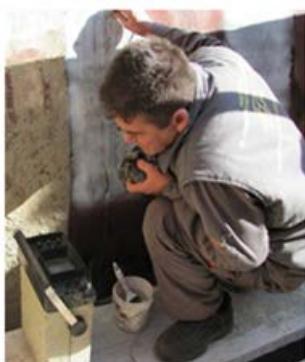
Ultrasonic testing was performed on parent material and weld metal [6] in order to determine depths of surface cracks. It was determined that cracks in parent material are

1,5-2,5 mm deep, while cracks in weld metal are 3,5-10,0 mm deep. Process of ultrasonic testing of the butt-welded joint, as well as location of the 10 mm deep surface crack are presented in figure 7.

a) Process of ultrasonic testing    b) Location of the 10 mm deep surface crack in the area of the butt - welded joint  
Figure 7. Determination of depths of surface cracks in the area of the butt-welded joint

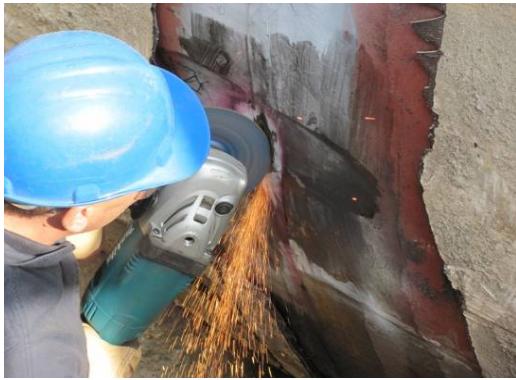
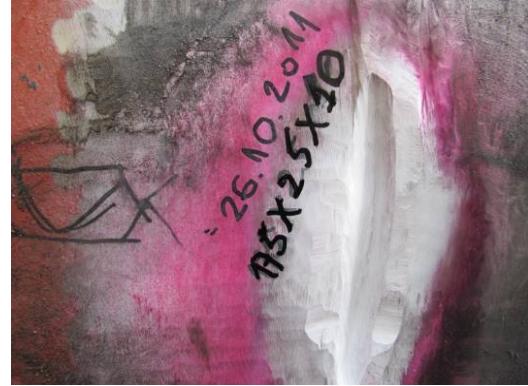
Figure 9. Appearance of the preparation for surface welding

a) Appearance of the repair of a cracked area

b) An area prepared for surface welding

Cracks at the surface of parent material were eliminated by fine grinding, while repair welding/surface welding had to be performed in areas at the surface of weld metal where cracks were detected after the grinding was finished through the utilization of welding procedure 111 with electrode EVB 50 (Jesenice electrodes), classified in accordance with the adequate standard [9]. Chemical composition of weld metal is presented in table 3, while mechanical properties are presented in table 4. In figure 9 the repair of the area where the longest and deepest crack was detected is shown. During and after the repair of cracked areas visual and magnetic particle/penetrant testing were performed.
