MEETING POINT OF THE SCIENCE AND PRACTICE IN THE FIELDS OF
CORROSION, MATERIALS AND ENVIRONMENTAL PROTECTION

Mechanisms and morphologies of cavitation damage of NN 70 steel *Mehanizmi i morfologije kavitacionog oštećenja čelika Nionikral 70*

Vujadin Aleksić^{1,*}, Marina Dojčinović², Ljubica Milović², Bojana Aleksić³, Ana Prodanović³

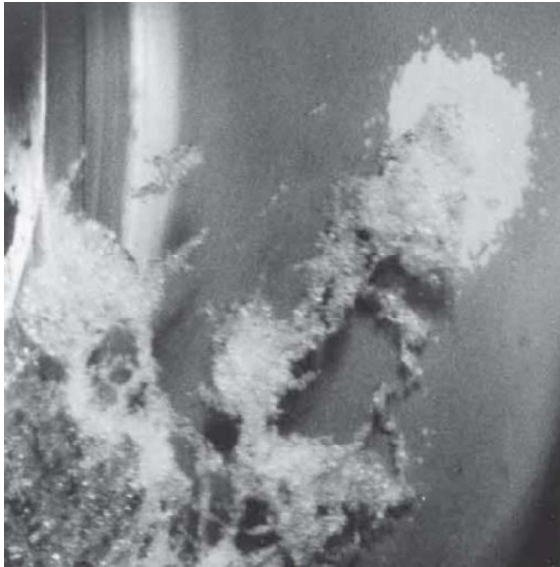
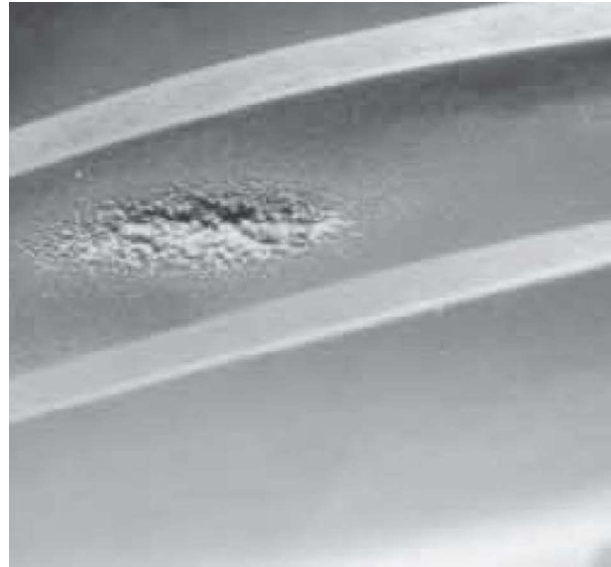
Due to changes in fluid pressure or the influence of rigid boundaries, cavitation bubbles generally deviate from a spherically symmetrical shape. The bubbles implode forming a micrometer that damages the surface to which it is directed, as can be seen in Figs. 1.

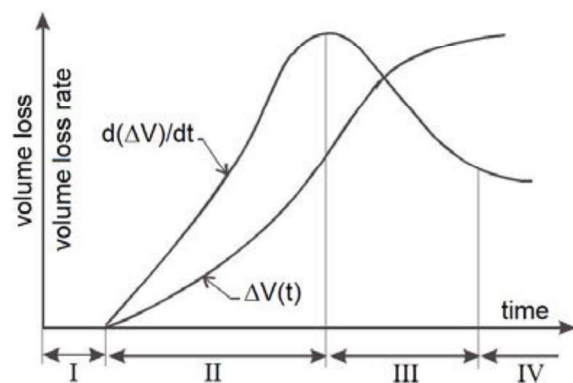
Figure 2. Characteristic cavitation erosion curves

a) Weight loss [3,4,5]

b) Volume loss [6]

The curves of Figs. 2a and b, obtained experimentally, provides a link between mass loss, ie volume, and cavitation action time, and shows four characteristic cavitation destruction periods.

The first period (t_0), (I), is the so-called. incubation period, when there is practically no loss of mass or volume due to the effect of cavitation. During this period the material accumulates energy and plastic deformation begins with a noticeable appearance of micro and macro reliefs. During this period, fatigue processes and material reinforcement may occur. During this period, only minor surface damage to the shape of the pits resulting from the loss of microscopic particles from different places on the surface occurs. Determining the duration of this period depends on the accuracy of the measurement of the samples during testing.

The second period (t_1), (II), is the period of onset of slight destruction of the surface layer followed by minimal mass loss. When the limit of deformation reinforcement is reached, continuous plastic deformation leads to the separation of the material and the formation and propagation of cracks near the surface, resulting in the removal of the material or the appearance of loss of mass of the material. The damaged surface becomes rougher with many small bumps.

The third period (t_2), (III), is the period of accelerated destruction followed by pronounced mass loss. Small craters formed in the previous period merge to form entire pits on the surface layer exposed to the effect of cavitation. Cavitation velocity can be increased to its maximum value due to deformation of the surface and crack development. The degree of increase in cavitation velocity will depend on the type of material and cavitation conditions. When mass loss begins, surface characteristics change, cracks, deep pits occur, and fatigue becomes more apparent. During this period, the loss of part of the volume reaches its maximum value.

The fourth period (t_3), (IV), is the period in which slow destruction occurs, but the pits continue to merge and form large craters on the surface exposed to cavitation. The decrease in cavitation velocity during this period depends on many factors such as material properties, the interaction between the fluid flow and the worn surface through the straightening process. Residual air or gas bubbles in deep craters can also act as a cushion and absorb some of the impact energy. This is a period of slow destruction, but the craters still merge and form large cavities and openings on the surface exposed to cavitation. The damaged area corresponding to this period is generally rougher with wider craters. This stage of cavitation only occurs under certain conditions.

In the third period, (III), a decrease in cavitation damage was observed. Volume loss is reduced. This is explained by filling the pits with water.

The last, fourth (IV), period is characterized by almost constant erosion-induced volume loss.

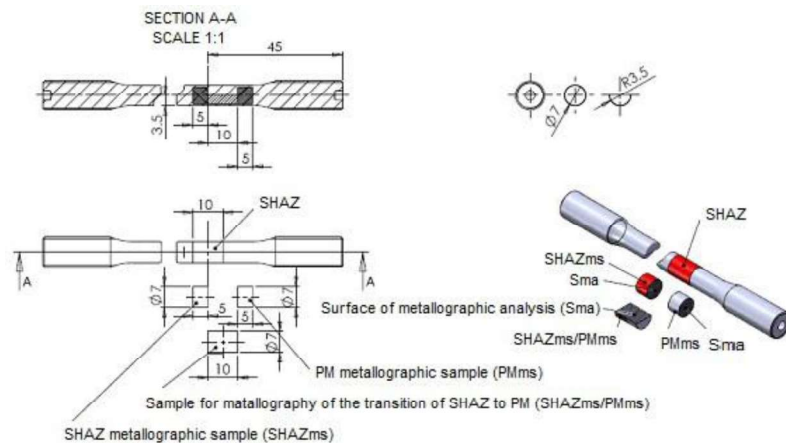
Figure 6. Metallographic testing specimens made from LCF SZUT sample 07 [9]
