5th International Quality Conference

MICROSTRUCTURE AND CHARACTERISATION OF QUALITY WATER PIPES AFTER 50 YEARS IN SERVICE

Abstract: Grey cast iron is the most common material used in-service water pipes and water distribution in Serbia. It is also a material which has the largest number of damages and failures per kilometer of pipeline per year. However, during a long service period, because of the surrounding environment (soil), decreases the quality and reliability of this material, so that after fifty years of work, the pipe is damaged, and the usefulness of reduced or completely eliminated. It was found that the graphitization, ie. graphitic corrosion in those pipes, is the most responsible for their degradation, with the entire water system in the city is becoming unreliable.

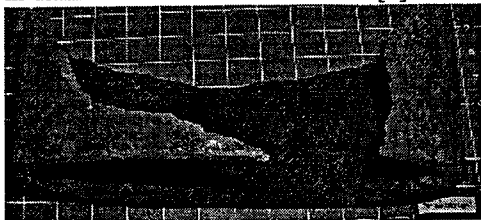
Figure 1 – Heavily corroded gray cast iron pipe

Investigation of the effects of corrosion on gray cast iron failures in particular is complicated by the presence of two separate but closely related corrosion processes that may affect the pipes. Simple corrosion pitting can occur in much the same way as steel pipes. However, graphitisation can also take place [2]. This process removes some of the iron in the pipe, but leaves behind a

matrix of graphite flakes that is held together in part by iron oxide, see Figure 1.
