INTEGRITY ASSESSMENT OF VITAL BEAM COMPONENTS THAT ENABLE CONJOINT OPERATION OF TWO BRIDGE CRANES

Originalni naučni rad / Original scientific paper

Inspection, conditional analysis and testing of beam components for simultaneous conjoint operation of 2 bridge cranes with overall lifting capacity of 500 t (5 MN) are performed as a preparation for work during rehabilitation or

major overhaul of hydroelectric generating set equipment at the hydro power plant ‘Djerdap 2’, because they are subjected to regulations for load lifting devices.

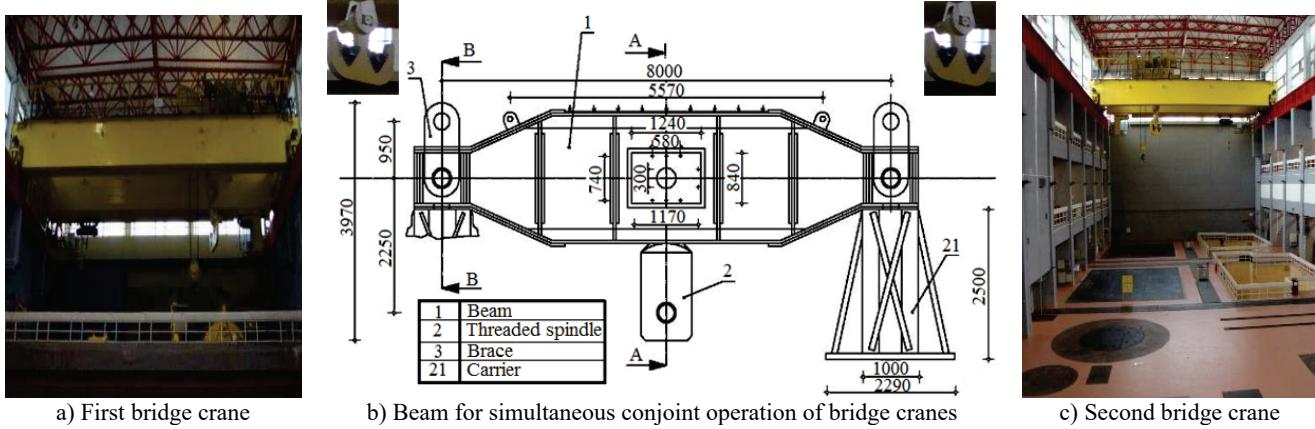
Figure 1. Appearance of the beam for simultaneous conjoint operation of 2 bridge cranes.

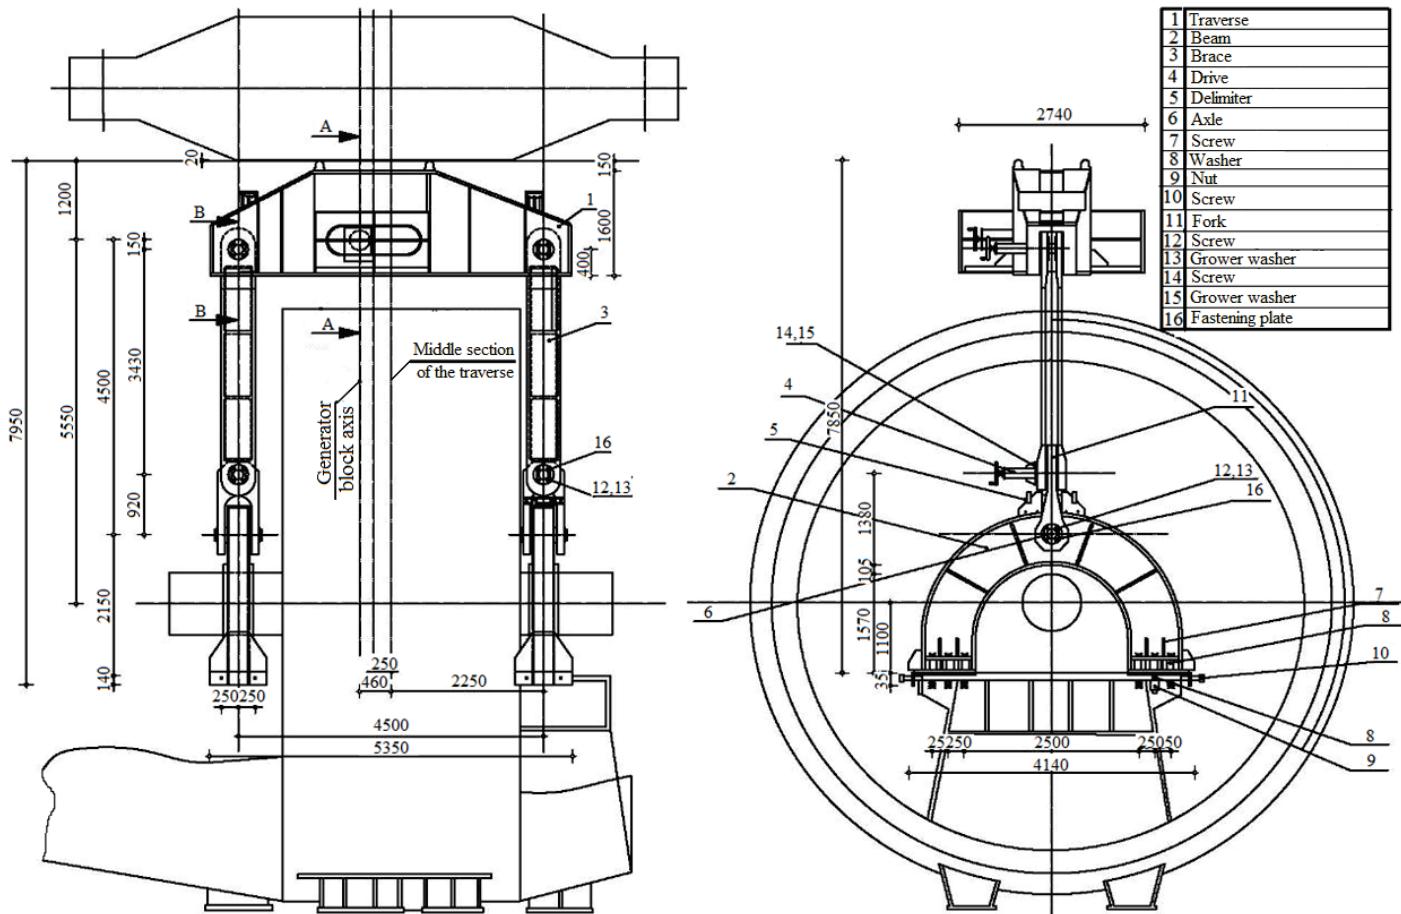
Figure 2. Assembly drawing of the device for simultaneous conjoint operation of 2 bridge cranes.

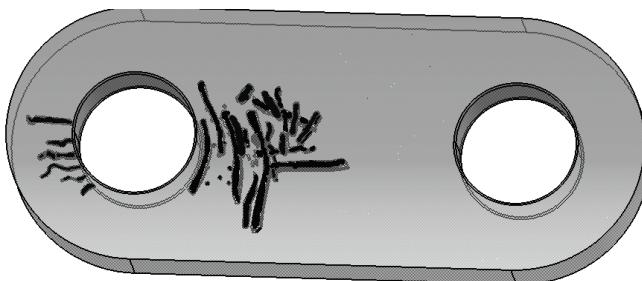
In Figs. 3 and 4, results of tests carried out on the right brace of beam (where internal non-homogeneities are detected), as well as on the threaded spindle, are presented. Findings, marked by red and yellow colour, refer to areas where the tests were carried out.

Figure 3. Results of ultrasonic testing performed on the right brace of the beam (upper view).

On the basis of results of ultrasonic tests performed on the right brace and threaded spindle, shown in Figs. 3-6, it can be concluded that detected non-homogeneities are discontinuous impurities of lamellar shape grouped around the central area that originated during the process of forging, which is a relatively common occurrence during the manufacture of large forgings.

- Based on reports OZPTT-ZA-01/013 UT for the right brace of the beam /4/ and OZPTT-VR-01/013 UT for the threaded spindle /5/, shown in 3D in Figs. 3 and 4, impurities of lamellar shape that occurred during the process of forging are detected locally. These impurities are grouped close to the central area, which is a relatively common occurrence during the manufacture of large forgings.

It can generally be concluded that non-allowable indications detected at the right brace and at the threaded spindle by ultrasonic tests do not influence the load carrying capacity of the equipment for simultaneous conjoint operation of

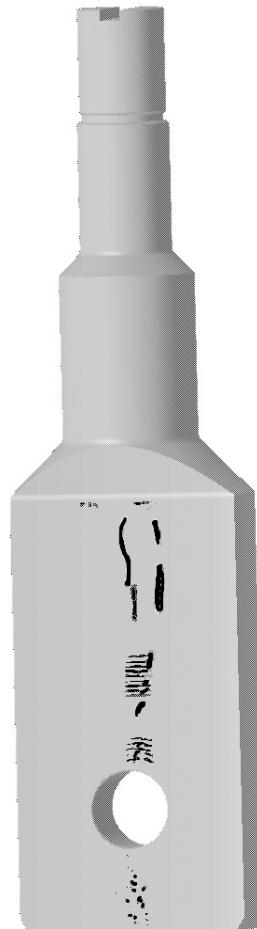
Figure 4. Indications of ultrasonic testing performed on the threaded spindle of the beam (upper view).

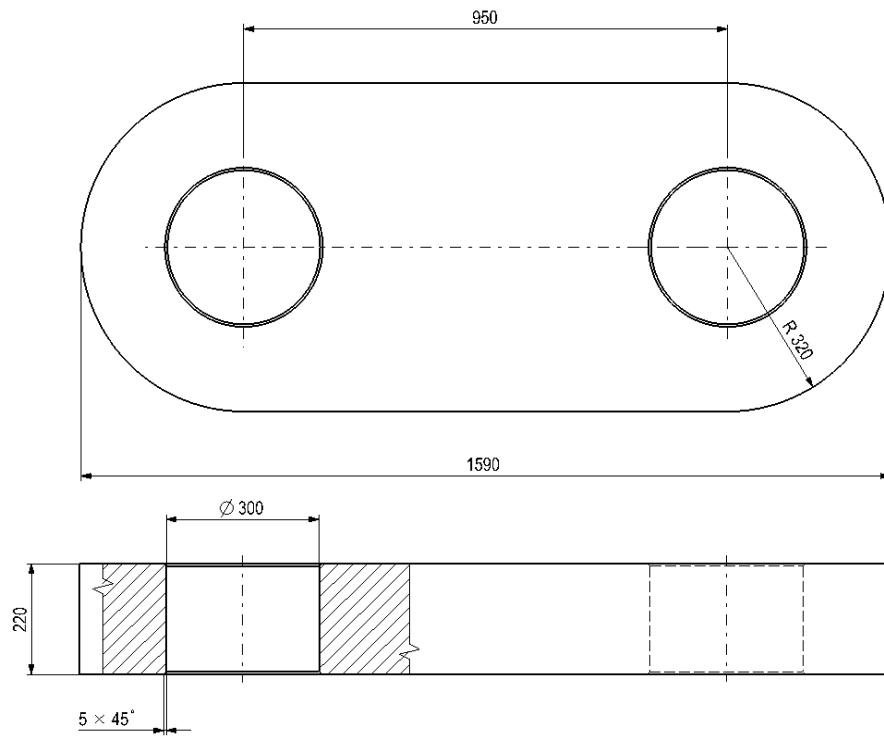
Beam braces are subjected to tension, each with 250 t (2.5 MN). Nevertheless, their analytical calculation is carried out for a load of 500 t (5 MN) in order to achieve safety in case when one of the braces fails. Dimensions and critical cross-sections used for the analytical calculation of beam braces are shown in Figs. 5 and 6.

Figure 5. Basic dimensions of beam brace.

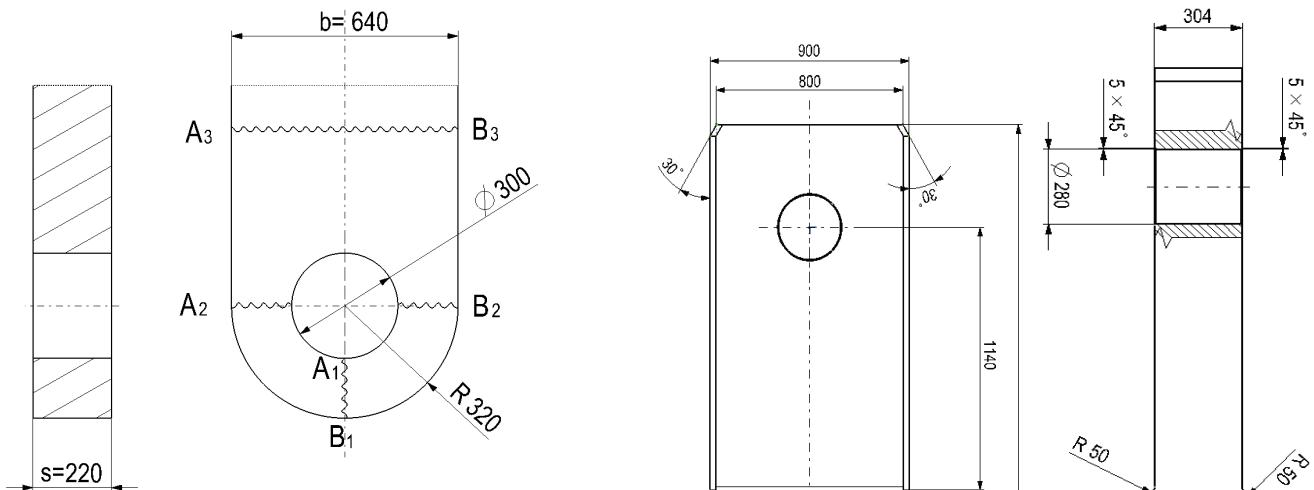
Figure 6. Detail around the opening at the brace with marked characteristic cross-sections.

The analytical calculation for the beam braces has determined the safety factor to be equal or larger than 2 in all critical cross-sections, shown in Fig. 8, /2/.

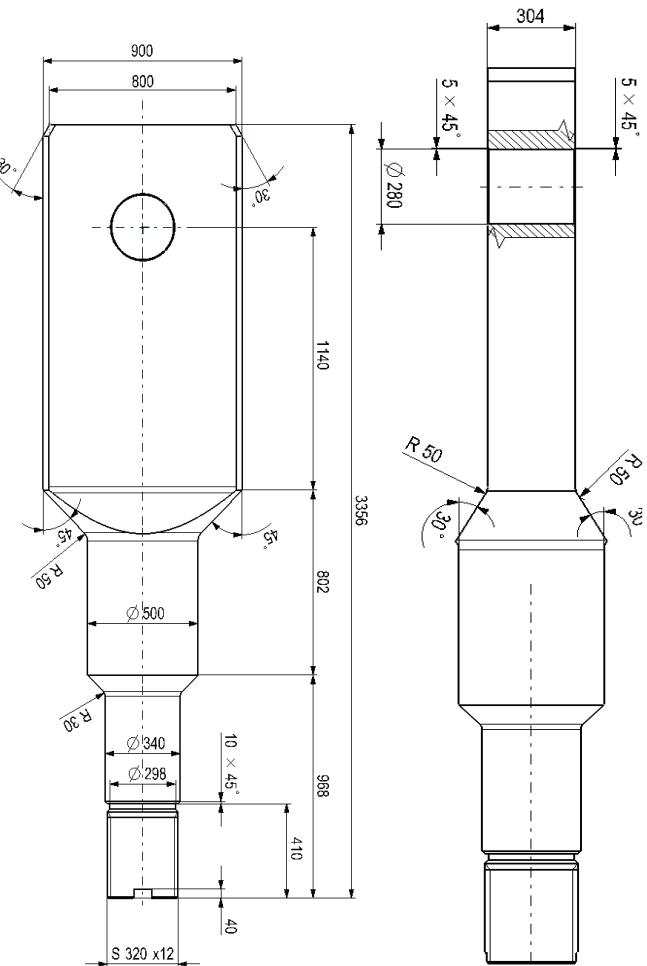
Figure 7. Basic dimensions of the threaded spindle.

Analytical calculation is performed for all characteristic cross-sections of the threaded spindle, which served as a basis for determining the minimal necessary diameter of the threaded segment. Dimensions and critical cross-sections are shown in Figs. 7 and 8.

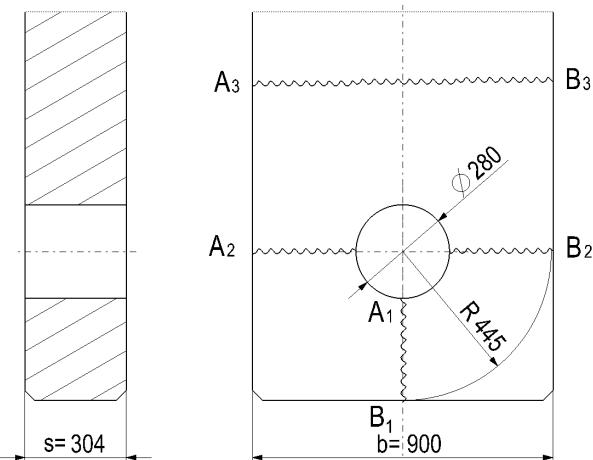
Figure 8. Detail around the eye opening at a threaded spindle with marked characteristic cross-sections

Analytical calculation of the threaded spindle in critical cross-sections, as shown in Fig. 10, has determined the lowest value of the safety factor at 1.67, /2/.

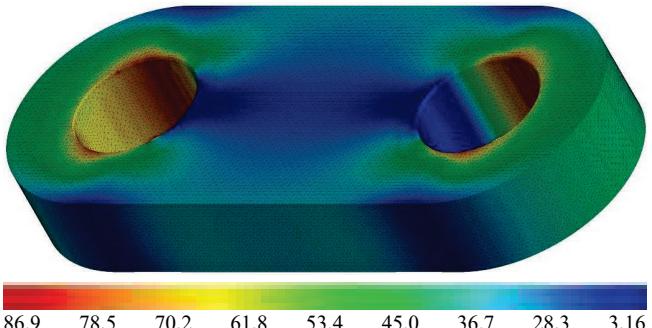
The 3D model of the brace is shown in Fig. 11a, while mesh of finite elements is presented in Fig. 11b. The mesh has 3438027 finite elements and 78755 nodes. Results of numerical calculation of tensile stress to which the brace is subjected for load of 5 MN that includes the use of von Mises equations is presented in Fig. 9.

Figure 9. Results of numerical calculation and values of von Mises tensile stresses in MPa.

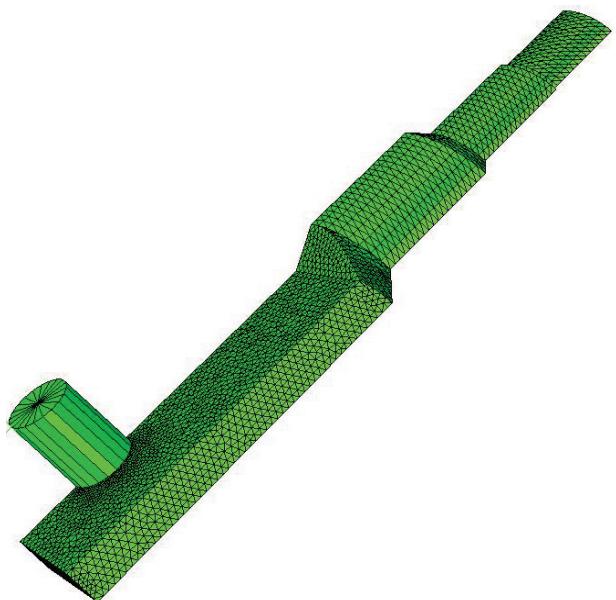
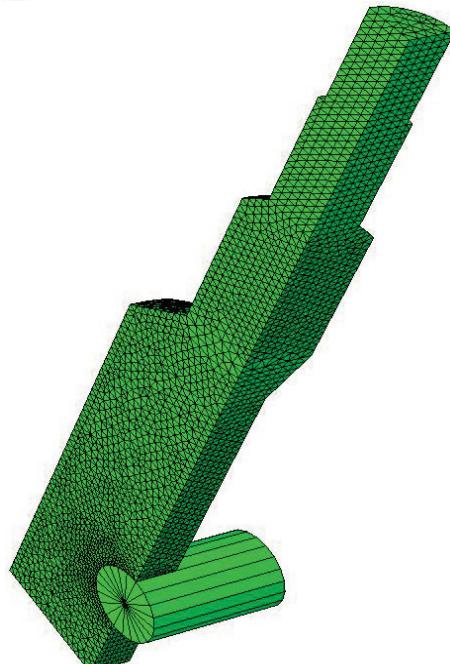
Finite element model is formed by using two planes of symmetry and adequate boundary conditions, taking into account the geometry of the threaded spindle, Fig. 10. The load is introduced using the contact with a rigid body (shaft), as presented in the same figure. The linear elastic model of material behaviour is used. Calculation is performed taking into account that braces are subjected to

Figure 10. Mesh of finite elements of the threaded spindle.

The mesh consists of tetrahedral finite elements with square interpolation functions. The acting load on the model of 1 250 000 N presents 25 % of service load. The load acts on the shaft and is transferred by contact on the spindle. Connection of the spindle with the crane (through threaded coupling) is simplified in the model – the movement of the surface which responds to the threaded segment of the spindle is prevented.

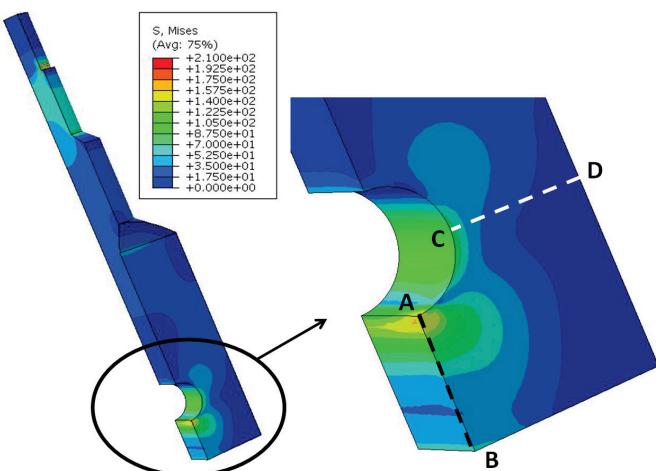
Distribution of von Mises stresses is presented in Fig. 11, which also contains magnified detail at the threaded spindle in close proximity of the opening. In Figs. 11 and 12 the shaft is not shown in order for the complete distribution of stresses to be presented. It is clear that the highest values of stress are significantly lower than 210 MPa, which is the value of yield stress.

The two paths (A-B and C-D) along which the variation of stress values are monitored are shown in Fig. 11, in order to determine the stress state in close proximity of the opening as precisely as possible.

Figure 11. Distribution of equivalent von Mises stress.

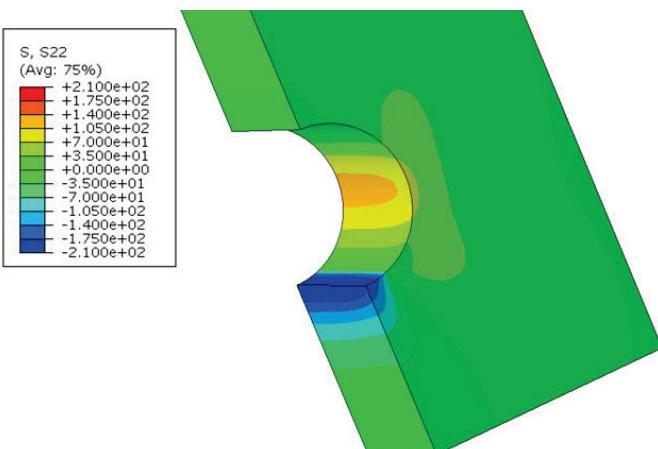
Figure 12. Stress distribution in the longitudinal direction, area of the opening.

The distribution of stresses in the longitudinal direction (axial stress) around the opening, with negative values of this component due to contact with shaft (i.e. to transfer of load across the contact surface) is shown in Fig. 13.

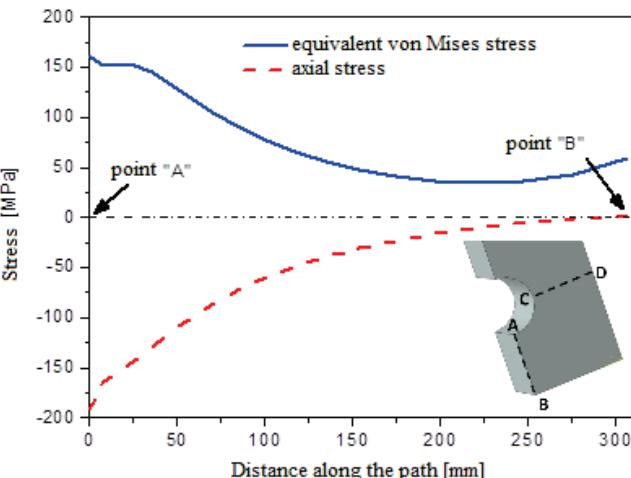
Variations of stress along the paths A-B and C-D are presented in Figs. 13 and 14. Equivalent Von Mises stress

has higher values along the first path, due to the evident negative stress in the longitudinal direction.

Figure 13. Variation of stress value along the path A-B.

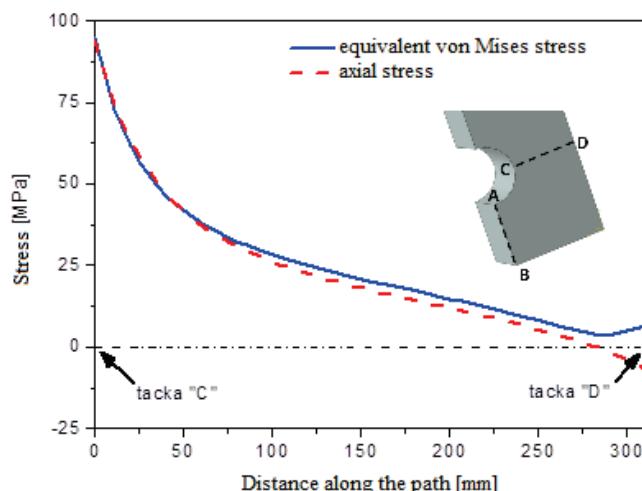
Figure 14. Variation of stress value along the path C-D

In cross-section C-D the values of von Mises stress and of the stress in the longitudinal direction are almost equal, with the highest value at the very opening (point C) of approximately 90 MPa.
