The role of drainage systems in the prevention of material degradation of bridge structures

Vujadin Aleksić^{1,*}, Bojana Zečević², Srđan Bulatović¹, Ana Maksimović², Ljubica Milović³

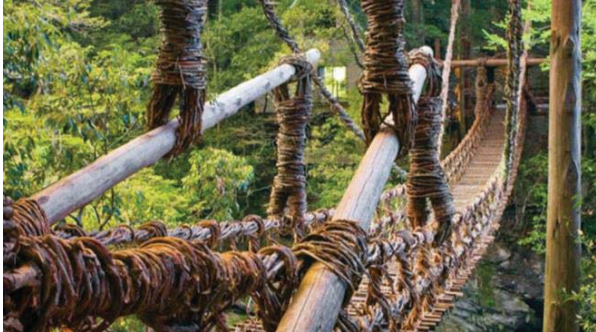
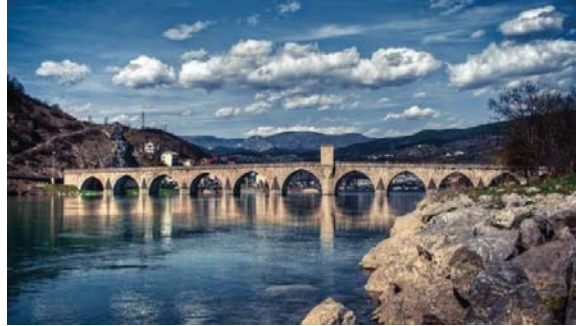
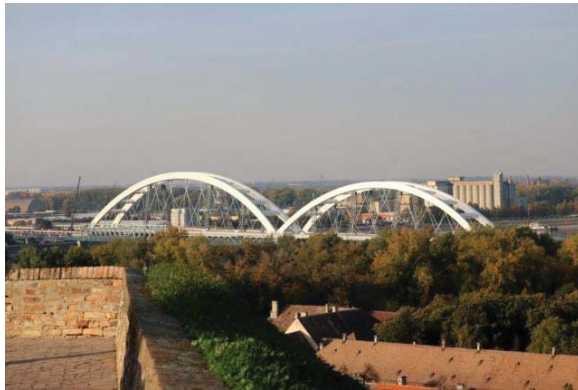
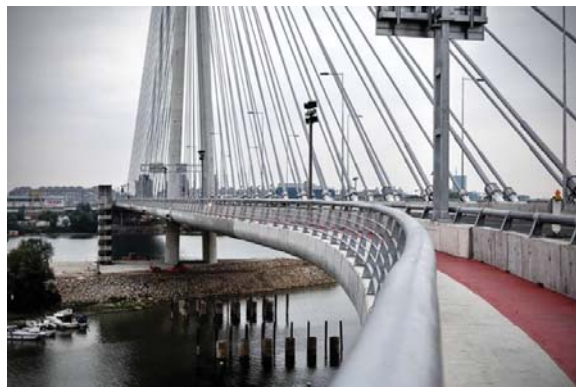
Figure 1. Bridge constructions of different materials and various applications

a) Pedestrian bridge made of plant ropes and trees [5]

b) Stone road pedestrian bridge [6]

c) Road railway metal concrete bridge [7]

d) Road railway pedestrian bicycle reinforced prestressed concrete bridge with steel ropes [8]

Bridges are buildings made of different materials and are used for bridging roads over obstacles, especially over watercourses. They can be pedestrian, bicycle, road, railway or a combination of the above, Fig.1. They differ according to the construction and the type of main building material. For the choice of construction, the conditions of foundation, aesthetic value, the minimum required span, the height of the bridge as well as the anticipated load are important.

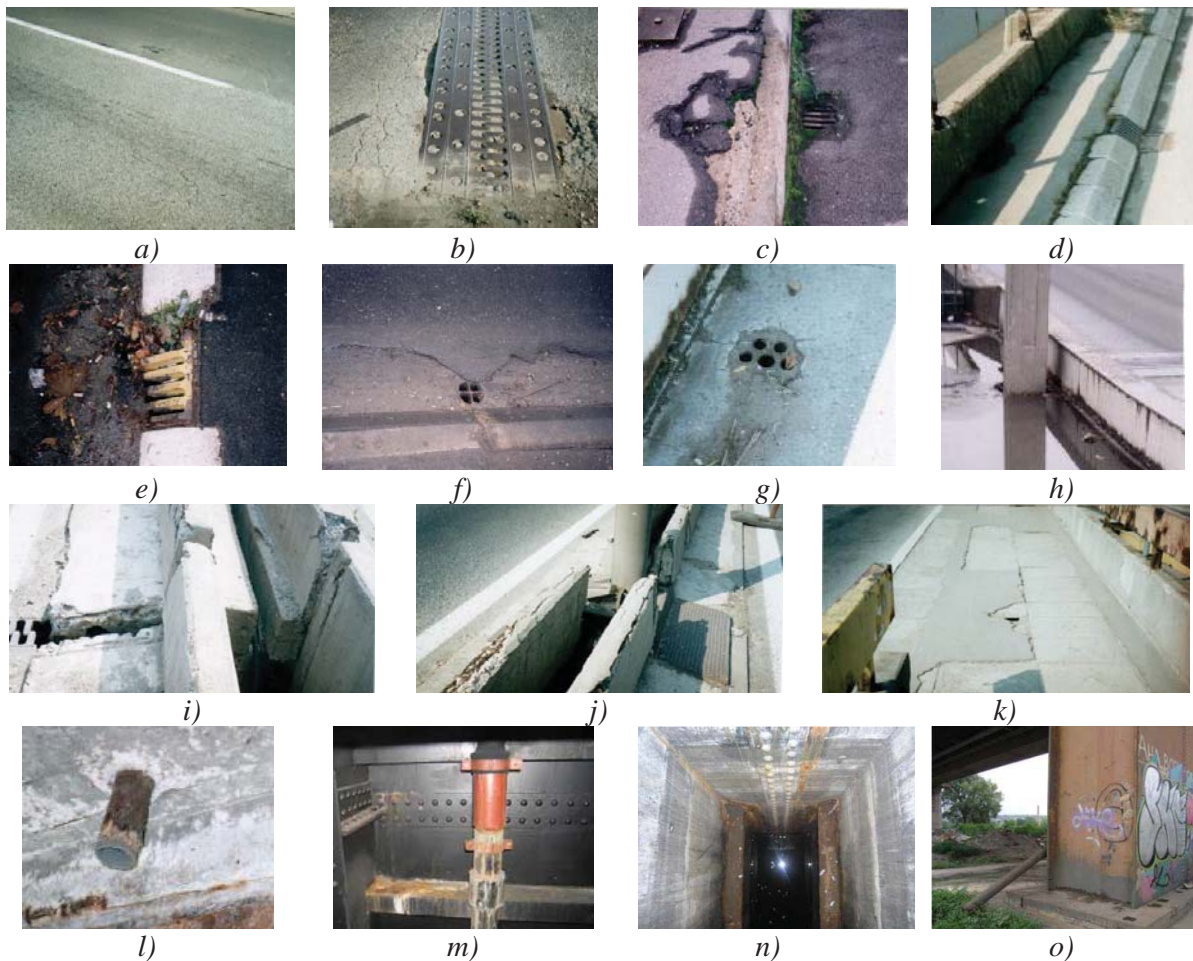
Figure 4. Degradation of the drainage system of bridges and materials around it [10, 11]

In fig. 4 shows examples of asphalt degradation and bridge drainage systems:

- a) Mesh cracks, porous asphalt and depressions on the road.
- b) Damage to the pavement in the zone of the expansion joint which is filled with dirt. The space between the combs is filled with dirt on the parts along the protective tape.
- c) Drain on the tram facility; accumulated dirt around the perimeter of the grille.
- d) Drains are placed partly in the curb and partly in the road.
- e) Damaged gutter grate with deposits of garbage and dirt.
- f) Steel grate across the river.

- g) Detail of the drain grate.
- h) Water retention on the footpath.
- i) Detail on the confrontation of structures.
- j) Detail of the parapet on the structure at the location of the lighting pole.
- k) Detail of track fences on the bridge structure.
- l) Corrosion of the lower part of the drain.
- m) Corrosion in place of drainage pipes.
- n) The bottom of the pillar is filled with water with traces of falling water levels on the inner walls of the pillar.
- o) Appearance of the outer surface and foundation of the pillar with ACP in the form of graffiti and a system for drainage of the bridge that ends in grass.

Due to untimely and inadequate maintenance of the bridge drainage system, the system becomes non-functional and degrades, and indirectly the material from which the bridges are made.

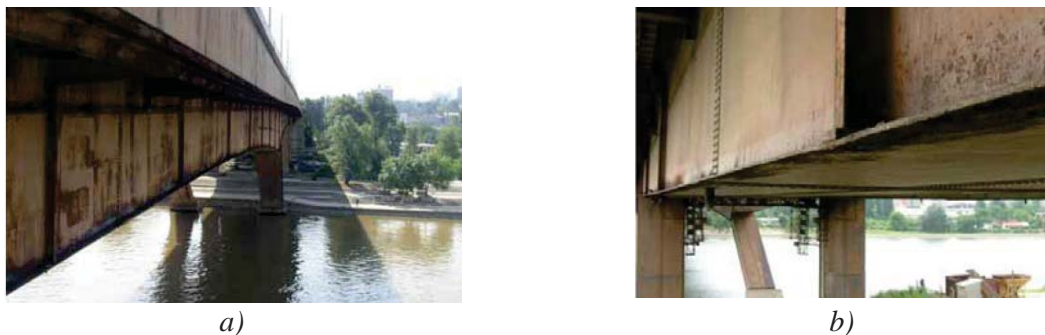
Figure 7. Degradation of steel structural parts. Examples of corrosion damage of steel bridges [11]

Fig. 7 represents:

- a) View of the main girder damaged by corrosion.
- b) Corrosion of the bottom plate of the main girder.
- c) Corrosion of the footpath console. Downstream.

- d) Corrosion damage to the vertical sheet metal and the upper belt of the main girder. Upstream.
- e) Characteristic corrosion in the dividing strip zone. The middle of the bridge.

- f) Corrosion of the ortho plate in the zone of the dividing strip.
- g) Dirt deposits on the inspection track and the fall of the rubber gutter into the expansion space.

- h) Corrosion of the bottom plate with residue left after evaporation of water with lines showing the level of salted water before evaporation. Inside the bridge.

- i) Characteristic corrosion in the dividing strip zone. View of the ortho plate in the zone of the dividing strip.
- j) Rotten climbers and inspection trails with places of corrosion inside the pole.

- k) Appearance of hot water and plumbing installation and garbage at the bottom of the column.
- l) Corrosion of the connection between the lighting pole and the pedestrian path console.

- m) Deformation of the plate reinforcement at the point of support of the inclined pillar on the main girder.
- n) Exterior appearance of the lower part of the surface of the vertical metal pillar with accumulated dirt and debris at the base of the pillar.
