Microstructural analysis as the indicator for suitability of weld repairing of the heat resistant Cr - Ni steel^(*)

Metallurgical evaluation was performed on a fractured column tube of the reformer furnace in an ammonia plant. The tubes were manufactured from centrifugally cast heat resistant steel HK 40. Optical and scanning electron microscope (SEM) were used for microstructural and fracture analysis. For composition determination of the microconstituents energy dispersive X ray spectroscopy (EDS) was used. To evaluate mechanical properties, hardness and microhardness measurements were performed. Investigations based on the microstructural features with the idea to indicate suitability of weld repair of the column were performed in this study. It was observed that the crack initiation, caused by oxidation/corrosion and thermal stresses induced by temperature gradient, appeared in the inner side of the tube wall and propagation occurred along grain boundaries. The results clearly showed the presence of an irregular microstructure which contributed to crack propagation through the tube wall. An occurrence of precipitated needle-shaped carbides/carbonitrides and brittle σ phase was

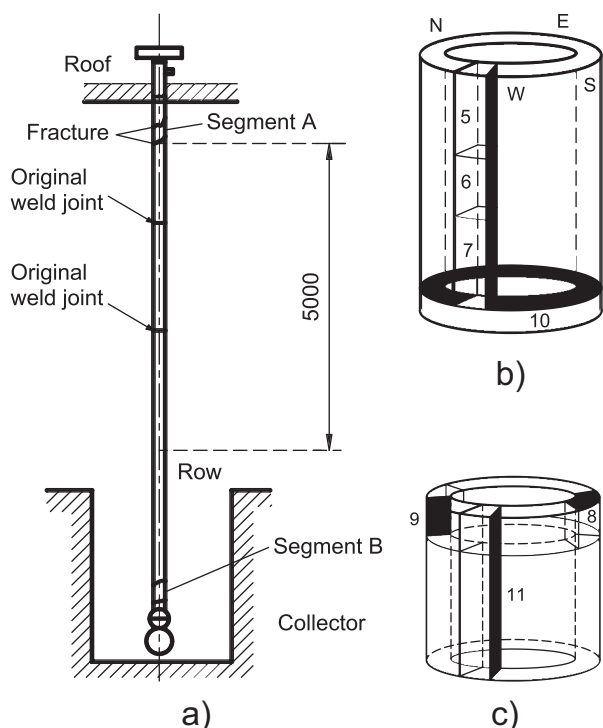
The fracture location of the damaged primary reformer is schematically shown in figure 1. Microstructural investigations of the material were performed on the segment near the location of fracture, designated as A, whereas the segment B on the other part of the reformer tube, where possible deformation did not occur, served as a reference sample. Segment A was collected from the part beneath the roof, while segment B was sampled from the location above the collector.

Figure 1. Schematic presentation of the primary reformer with tested segments designated as A and B. a) Location of the tested segments; b) Analyzed cross sections (gray) of segment A where fracture occurred; c) Segment B above collector with analysed sections.

Results of hardness measurements across the wall thickness of segments A and B (see figure 1) are shown in table V. Analysis of each group of results has shown that there is no distinguished difference in hardness, except on fractured segment A. Namely, near the inner surface somewhat lower hardness of the tube was found. The average hardness of the segment A is high compared to segment B.
