ANALIZA SLEGANJA TEMELJA USLED PROGRESIVNOG PROVLAŽAVANJA PRAŠINASTIH GLINA^{**}**

ANALYSIS OF FOUNDATION SETTLEMENT FROM PROGRESSIVE MOISTENING OF SILTY CLAY^{**}**

Examples of visible damage (cracks on the facade walls) on the shallow founded older buildings in Belgrade are not rare. Usually, this is a consequence of unequal settlement resulting from the unexpected moistening of soil under foundation. Moistening usually occurs locally and differential settlement is inevitable in such conditions. This paper presents the research results, which indicate that besides the size of impact zone of moisture change in the soil in horizontal direction and calculated settlement values, total change of soil volume under foundations should be analyzed.

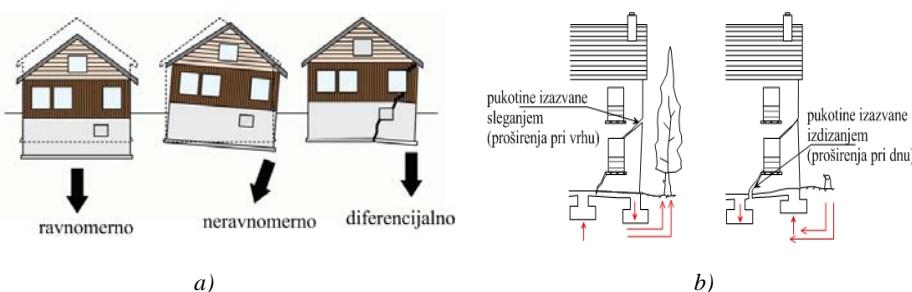
skupljanje tla, što opet može da izazove vidljive deformacije na objektu. Suprotno tome, odsustvo vegetacije vodi ka povećanju vlažnosti, ne retko i bubrenju gline-nih tla, koje ponekad može izazvati izdizanje objekta. Zbog toga se na objektima mogu javiti različiti vidovi deformacija [1]

Sl. 1. a) Opšti tipovi sleganja temelja, **b)** Pojava dijagonalnih pukotina u zidovima zbog diferencijalnih sleganja

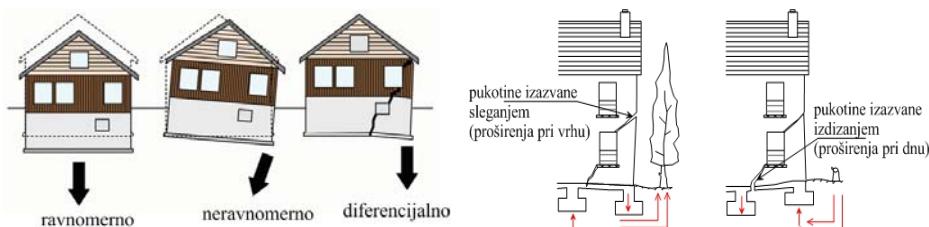
may appear on building [1] (Figure 1). Please note that during prolonged dry periods, the tree roots can mainly cause mechanical damages of the underground parts of a facility due to their growth in deeper and wetter parts of terrain.

Fig. 1. a) The general types of soil settlement, **b)** appearance of diagonal cracks in the walls due to differential settling
