ANALYSIS OF CAUSES OF DEGRADATION OF PARENT MATERIAL AND WELD METAL OF BREECHES PIPE AT HYDRO POWER PLANT 'PERUĆICA'

Originalni naučni rad / Original scientific paper

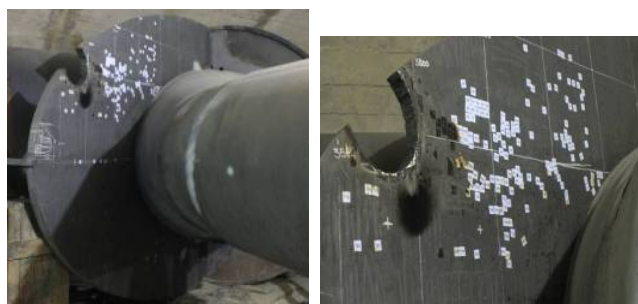
Locations of samples needed for determination of chemical composition, tensile properties, impact energy and hardness are shown in Fig. 6.

Figure 6. Locations of samples for destructive tests.
