## Analiza stanja vitalne čelične konstrukcije kabine rukovaoca rotornog bagera nakon havarije i sanacije

U radu je prikazana analiza stanja vitalne čelične konstrukcije kabine rukovaoca rotornog bagera DU 2, izrađene od cevi različitih prečnika i debljina lima, nakon havarije izazvane udarom kamena u poprečni nosač konstrukcije. Kamen se nalazio u otkopanom uglju jedne od kašika rotora bagera. Prilikom udara kamena poprečni nosač konstrukcije kabine rukovaoca se savio i popucali su zavareni spojevi između prirubnica na sredini poprečnog

## State Analysis of the Vital Steel Structure of the Bucket-wheel Reclaimer Operators Cabin After the Breakdown and the Rehabilitation

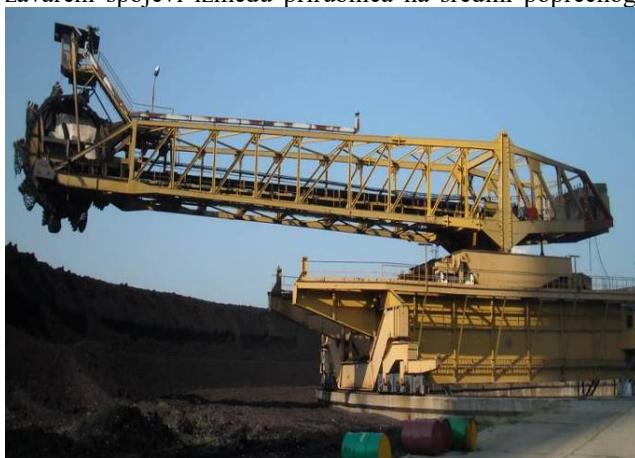
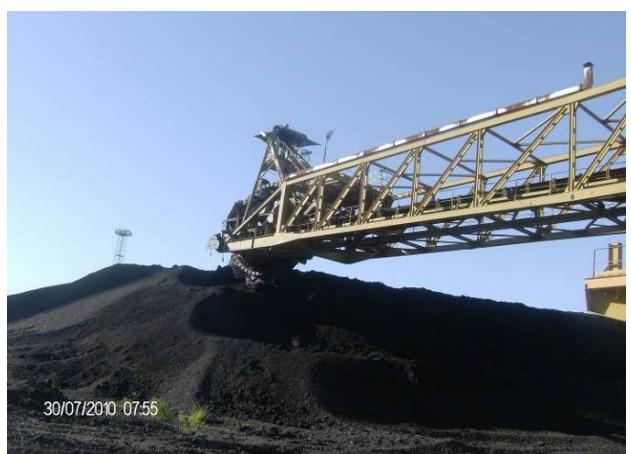
Slika 1. Prikaz rotornog bagera DU2 na deponiji uglja

a) Prikaz kompletног rotornog bagera

b) Prikaz rotornog bagera u radu

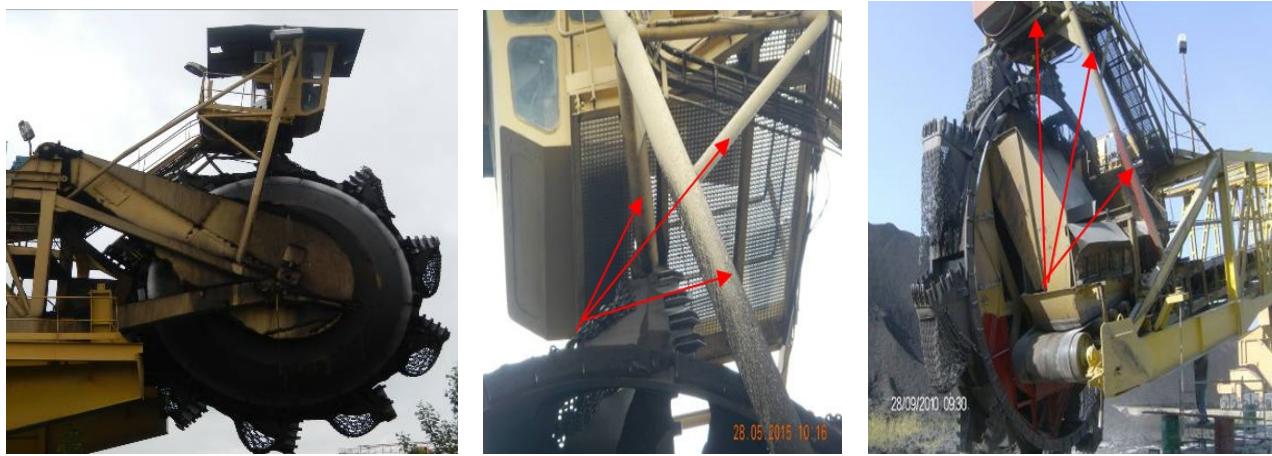
Slika 2. Prikaz rotora i vitalnih delova konstrukcije kabine rukovaoca bagera

a) Prikaz rotora i kabine rukovaoca bagera

b) Desna strana konstrukcije

c) Leva strana konstrukcije

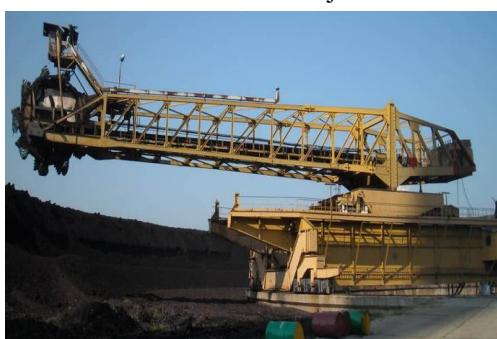
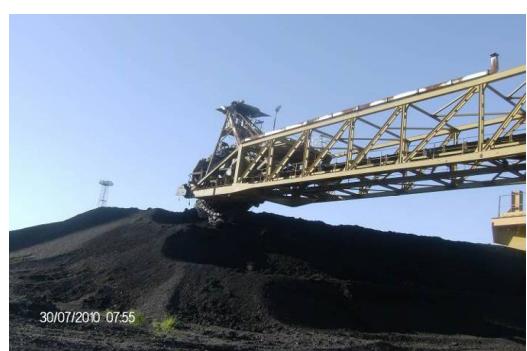
Figure 1: Appearance of the bucket-wheel reclaimer DU2 at the open pit surface mine

a) Appearance of the bucket-wheel reclaimer

b) Appearance of the bucket-wheel reclaimer in operation

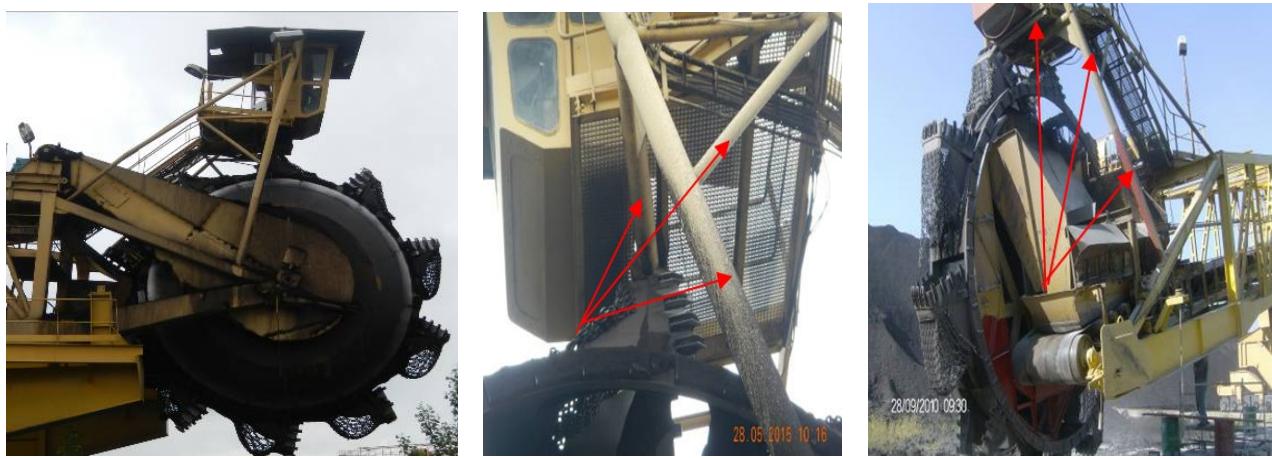
a) Appearance of the bucket-wheel and of the operators' cabin

b) Right side of the structure
